# Access Compliance Report

## Public Rights-of-Way

### (Curb Ramps)

Intersection ID: 27339	Main Street: BALLANTYNE_MEDICAL_PL	Cross Street: CONLAN_CR	Location: NE
ADA ID: 13CE8C13294C	Ramp Type: Perp	Initial Pass/Fail: Fail	Overall Compliance: No
			Severity Score: 21.25

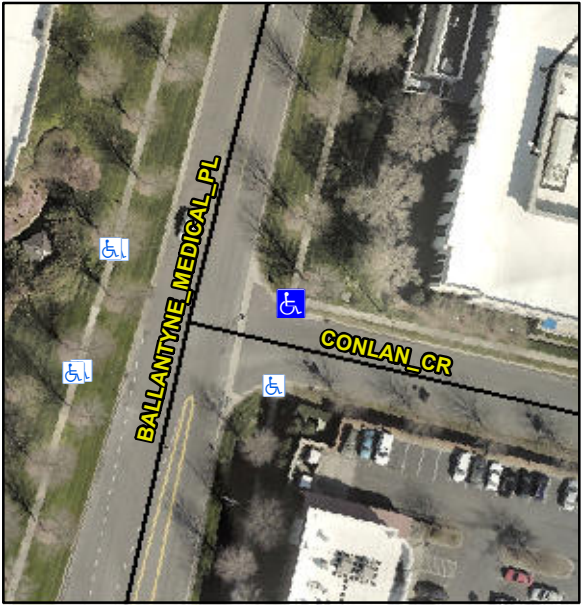
Possible Solutions:		<b>Compliance</b>	<b>Description</b>	<b>Data</b>
	<b>Remove &amp; Replace Entire Ramp.</b>		<b>No</b>	Ramp Length (in)	<b>94.0</b>
			<b>No</b>	Ramp Width (in)	<b>39.0</b>
			<b>N/A</b>	Flare Type LT	<b>N/A</b>
			<b>N/A</b>	Flare Slope LT (%)	<b>N/A</b>
			<b>N/A</b>	Flare Traversable LT?	<b>N/A</b>
			<b>N/A</b>	Landing Length (in)	<b>N/A</b>
			<b>N/A</b>	Landing Width (in)	<b>N/A</b>
			<b>N/A</b>	Landing Slope (%)	<b>N/A</b>
			<b>N/A</b>	Landing X Slope (%)	<b>N/A</b>
<p>Surveyor Notes:</p> <p><b>N/A</b></p>			<b>N/A</b>	Landing Curb? (Y/N)	<b>N/A</b>
			<b>N/A</b>	Shared Landing?	<b>N/A</b>
			<b>N/A</b>	Gutter Ponding?	<b>N/A</b>
			<b>N/A</b>	Gutter Lip Ht (in)	<b>N/A</b>
			<b>N/A</b>	Painted X Walk1?	<b>No</b>
				X Walk 1 Direction	<b>To SW</b>
			<b>N/A</b>	X Walk 1 Width (in)	<b>N/A</b>

X Walk 1 Slope (%)	<b>1.2</b>
				X Walk 1 X Slope (%)	<b>1.3</b>
			<b>N/A</b>	Ramp inside XWalk1?	<b>N/A</b>
<p>PROW/ADA:</p> <p><b>R304.5.1, R304.2.2</b></p>			<b>N/A</b>	Road Slope (%)	<b>N/A</b>
			<b>N/A</b>	Road X Slope (%)	<b>N/A</b>
			<b>N/A</b>	Any Obstructions?	<b>N/A</b>
				Obstruction Type	
			<b>N/A</b>		
			<b>N/A</b>		
			<b>N/A</b>		
			<b>N/A</b>		
			<b>N/A</b>		
			<b>N/A</b>		
<p>Street 1 Name</p> <p>Stop Condition-Street 2</p> <p>Street 2 Name</p> <p>Stop Condition-Street 1</p>			<b>N/A</b>	Clear Space?	<b>N/A</b>
			<b>N/A</b>	Clear Space to XWalk (in)	<b>N/A</b>
			<b>N/A</b>	Storm Grate/Utility Hazard?	<b>N/A</b>
				Storm Grate/Utility Type	
			<b>N/A</b>		
			<b>N/A</b>		
			<b>N/A</b>		
			<b>N/A</b>		
			<b>N/A</b>		
			<b>N/A</b>		
<p>Total Cost:</p> <p><b>\$ 1850.00</b></p>			<b>Yes</b>	Surface Condition? (G/P)	<b>Good</b>
