## Access Compliance Report Public Rights-of-Way (Curb Ramps)

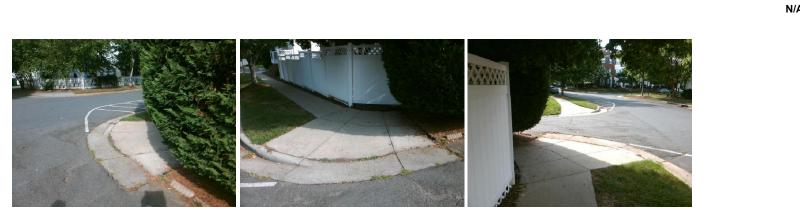
<b>`</b>		/						
Intersection ID: 10022822 Main Street: CASTLE_WATCH_AV Cross					N/A	Location:	NE			
ADA ID: 13D5D6A330DD Ramp Type: PerpDiag Initial					ail: Fail Overall (	o Severity Score:	8.75			
Codes/Mitigation Info/Possible Solution					Field Measurements/Component Compliance					
		Possible Solutions:		Compliance Description		Data Compliance Description		liance Description	Data	
		Remove & Replace Curb Ram	p With	N/A	Ramp Length (in)	109.0	Yes	Ramp Slope (%)	7.5	
		Two New Directional Ramps of	•	No	Ramp Width (in)	38.0	Yes	Ramp XSlope (%)	1.4	
		Equivalent.		N/A	Flare Type LT	N/A	N/A	Flare Type RT	N/A	
				N/A	Flare Slope LT (%)	N/A	N/A	Flare Slope RT (%)	N/A	
LA CONTRACTOR				N/A	Flare Traversable LT?	N/A	N/A	Flare Traversable RT?	N/A	
		i i i i i i i i i i i i i i i i i i i		N/A	Landing Length (in)	N/A	N/A	DWS Provided?	N/A	
18 - And A		Surveyor Notes:		N/A	Landing Width (in)	N/A	N/A	DWS Contrast?	N/A

S Case to		N/A		N/A	Landing Slope (%)	N/A	N/A	DWS Length (in)	N/A	
La				N/A	Landing X Slope (%)	N/A	N/A	DWS Full Width?	N/A	
belle sin ber			N/A	Landing Curb? (Y/N)	N/A	N/A	DWS Offset (in)	N/A		
			N/A	Shared Landing?	N/A					
Street Provent	THE STREET	PROW/ADA:		N/A	Gutter Ponding?	N/A	N/A	Gutter Slope (%)	N/A	
		R304.5.1		N/A	Gutter Lip Ht (in)	N/A	N/A	Gutter X Slope (%)	N/A	
		K304.3.1		N/A	Painted X Walk1?	No	N/A	Painted X Walk2?	No	
			N/A	X Walk 1 Direction	To SW		X Walk 2 Direction	To SE		
				N/A	X Walk 1 Width (in)	N/A	N/A	X Walk 2 Width (in)	N/A	
Street 1 Name CASTLE WATCH AV				11/4	X Walk 1 Slope (%)	1.0	11/2	X Walk 2 Slope (%)	2.9	
Stop Condition-Street 2	None				X Walk 1 X Slope (%)	4.6		X Walk 2 X Slope (%)	2.9 1.6	
Stop Condition-Street 2	N/A			N/A	• • • •	4.6 N/A	N/A	,	1.6 N/A	
				N/A	Ramp inside XWalk1?		N/A	Ramp inside XWalk2?	N/A N/A	
Stop Condition-Street 1	None				Road Slope (%)	4.7		Clear Space?

Road X Slope (%)	3.5	N/A	Clear Space to XWalk (in)	N/A	
				N/A	Any Obstructions?	N/A	N/A	Storm Grate/Utility Hazard?	N/A	
		Total Cost: \$	3200.00		Obstruction Type			Storm Grate/Utility Type		
						N/A			N/A
