# Access Compliance Report

## Public Rights-of-Way

### (Curb Ramps)

Intersection ID: 50866	Main Street: LAKEVIEW_RD	Cross Street: CUSHING_DR	Location: NW
ADA ID: 13DDC67E81BB	Ramp Type: Perp	Initial Pass/Fail: Fail	Overall Compliance: No
Codes/Mitigation Info/Possible Solution		Field Measurements/Component Compliance	
Severity Score: 21.25

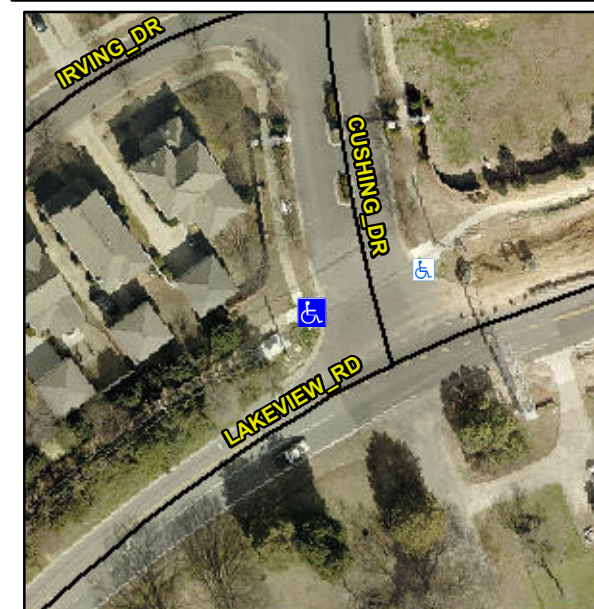
**Not Found, R304.5.1, R304.2.2**

Compliance	Description	Data	Compliance	Description	Data
N/A	Ramp Length (in)	95.0	No	Ramp Slope (%)	9.9
No	Ramp Width (in)	47.0	Yes	Ramp XSlope (%)	0.4
N/A	Flare Type LT	N/A	N/A	Flare Type RT	N/A
N/A	Flare Slope LT (%)	N/A	N/A	Flare Slope RT (%)	N/A
N/A	Flare Traversable LT?	N/A	N/A	Flare Traversable RT?	N/A
N/A	Landing Length (in)	N/A	N/A	DWS Provided?	N/A
N/A	Landing Width (in)	N/A	N/A	DWS Contrast?	N/A
N/A	Landing Slope (%)	N/A	N/A	DWS Length (in)	N/A
N/A	Landing X Slope (%)	N/A	N/A	DWS Full Width?	N/A
N/A	Landing Curb? (Y/N)	N/A	N/A	DWS Offset (in)	N/A
N/A	Shared Landing?	N/A			
N/A	Gutter Ponding?	N/A	N/A	Gutter Slope (%)	N/A
N/A	Gutter Lip Ht (in)	N/A	N/A	Gutter X Slope (%)	N/A
N/A	Painted X Walk1?	No	N/A	Painted X Walk2?	N/A
	X Walk 1 Direction	To E		X Walk 2 Direction	N/A
N/A	X Walk 1 Width (in)	N/A	N/A	X Walk 2 Width (in)	N/A
	X Walk 1 Slope (%)	1.7		X Walk 2 Slope (%)	N/A
	X Walk 1 X Slope (%)	0.0		X Walk 2 X Slope (%)	N/A

N/A	Ramp inside XWalk1?	N/A	N/A	Ramp inside XWalk2?	N/A
	Road Slope (%)	N/A	N/A	Clear Space?	N/A
	Road X Slope (%)	N/A	N/A	Clear Space to XWalk (in)	N/A
N/A	Any Obstructions?	N/A	N/A	Storm Grate/Utility Hazard?	N/A
	Obstruction Type			Storm Grate/Utility Type	
		N/A			N/A
			Yes	Surface Condition? (G/P)	Good

Possible Solutions:

**Remove & Replace Entire Ramp.**

Total Cost: \$ 1850.00
