# Access Compliance Report

## Public Rights-of-Way

Intersection ID: 27452	Main Street: BALLANTYNE COMMONS PY	Cross Street: BALLANTYNE CORPORATE PL	Location: SE
ADA ID: 13DFE4B3DA67	Ramp Type: Perp	Initial Pass/Fail: Fail	Overall Compliance: No
Severity Score: 43.75			
Codes/Mitigation Info/Possible Solution		Field Measurements/Component Compliance

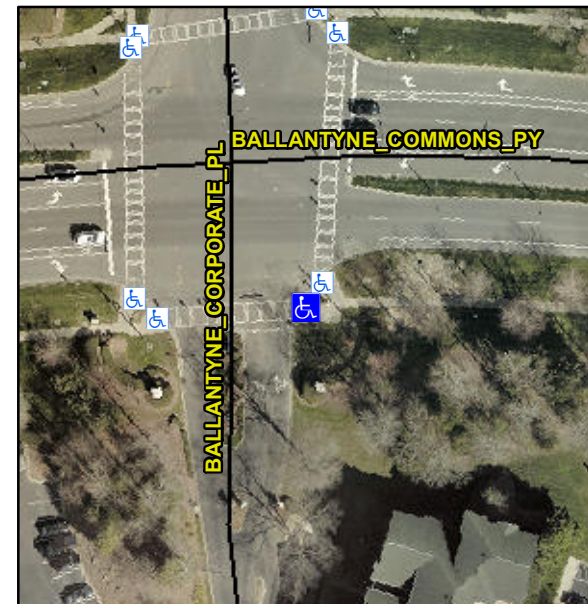
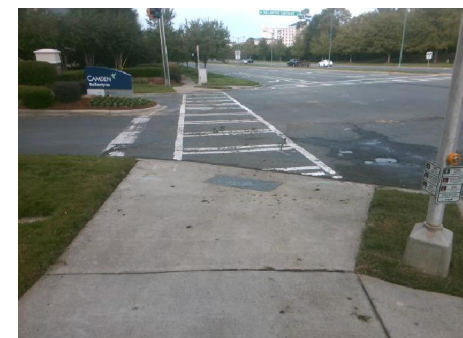
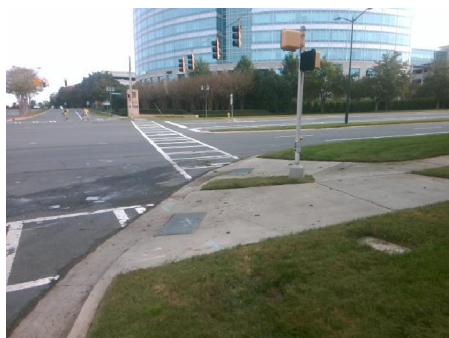
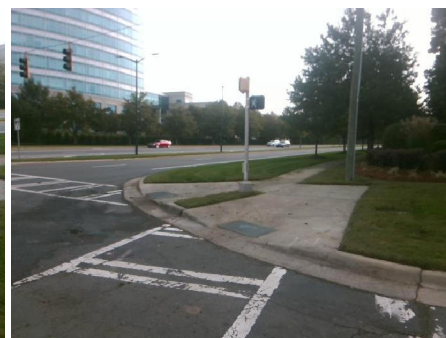
**Not Found, R304.5.1, R304.2.2, R304.5.3**

Compliance	Description	Data	Compliance	Description	Data
N/A	Ramp Length (in)	157.0	No	Ramp Slope (%)	14.6
No	Ramp Width (in)	33.0	No	Ramp XSlope (%)	2.5
N/A	Flare Type LT	N/A	N/A	Flare Type RT	N/A
N/A	Flare Slope LT (%)	N/A	N/A	Flare Slope RT (%)	N/A
N/A	Flare Traversable LT?	N/A	N/A	Flare Traversable RT?	N/A
N/A	Landing Length (in)	N/A	N/A	DWS Provided?	N/A
N/A	Landing Width (in)	N/A	N/A	DWS Contrast?	N/A
N/A	Landing Slope (%)	N/A	N/A	DWS Length (in)	N/A
N/A	Landing X Slope (%)	N/A	N/A	DWS Full Width?	N/A
N/A	Landing Curb? (Y/N)	N/A	N/A	DWS Offset (in)	N/A
N/A	Shared Landing?	N/A			
N/A	Gutter Ponding?	N/A	N/A	Gutter Slope (%)	N/A
N/A	Gutter Lip Ht (in)	N/A	N/A	Gutter X Slope (%)	N/A
N/A	Painted X Walk1?	Yes	N/A	Painted X Walk2?	N/A
	X Walk 1 Direction	To W		X Walk 2 Direction	N/A
N/A	X Walk 1 Width (in)	125.0	N/A	X Walk 2 Width (in)	N/A
	X Walk 1 Slope (%)	5.7		X Walk 2 Slope (%)	N/A
	X Walk 1 X Slope (%)	1.0		X Walk 2 X Slope (%)	N/A

N/A	Ramp inside XWalk1?	Yes	N/A	Ramp inside XWalk2?	N/A
	Road Slope (%)	N/A	N/A	Clear Space?	N/A
	Road X Slope (%)	N/A	N/A	Clear Space to XWalk (in)	N/A
N/A	Any Obstructions?	N/A	N/A	Storm Grate/Utility Hazard?	N/A
	Obstruction Type			Storm Grate/Utility Type	
		N/A			N/A
			Yes	Surface Condition? (G/P)	Good

**Remove & Replace Entire Ramp.**

Total Cost: \$ **1850.00**
