Access Compliance Report Public Rights-of-Way (Curb Ramps)

Intersection ID: 10033236	Main Street: OAK_LAKE_BV	Cros	Cross Street: N/A				Location: E		
ADA ID: 13E6552E926A	Ramp Type: PerpDiag		Initial Pass/Fail: Fail Overall Complian			nce: No Severity Score: 8.75		8.75	
Codes/Mitigation Info/Possible Solution			Field Measurements/Component Compliance						
	Possible Solutions:	sible Solutions: <u>Co</u>			Compliance Description Data			Data	
	Remove & Replace Cu	rb Ramp With	N/A	Ramp Length (in)	36.0	Yes	Ramp Slope (%)	5.3	
	Two New Directional R	•	No	Ramp Width (in)	46.0	Yes	Ramp XSlope (%)	1.4	
	Equivalent.	-	N/A	Flare Type LT	N/A	N/A	Flare Type RT	N/A	
			N/A	Flare Slope LT (%)	N/A	N/A	Flare Slope RT (%)	N/A	
	Sec. 1		N/A	Flare Traversable LT?	N/A	N/A	Flare Traversable RT?	N/A	
			N/A	Landing Length (in)	N/A	N/A	DWS Provided?	N/A	
	Surveyor Notes:		N/A	Landing Width (in)	N/A	N/A	DWS Contrast?	N/A	
	NA		N/A	Landing Slope (%)	N/A	N/A	DWS Length (in)	N/A	
			N/A	Landing X Slope (%)	N/A	N/A	DWS Full Width?	N/A

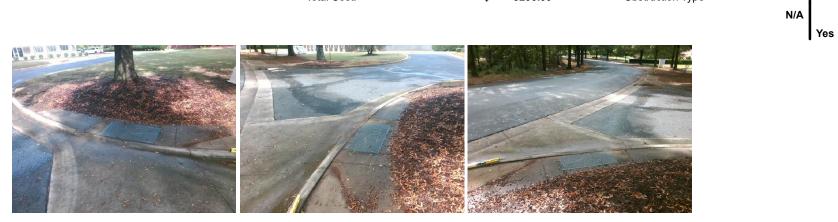
Company in the		N/A	Landing Curb? (Y/N)	N/A	N/A	DWS Offset (in)	N/A	
A MARINE MARINE	Contraction of the second seco		N/A	Shared Landing?	N/A				
THE A MARKED F	PROW/ADA:		N/A	Gutter Ponding?	N/A	N/A	Gutter Slope (%)	N/A	
A State of the second state of the	Not Found, R304.5.1		N/A	Gutter Lip Ht (in)	N/A	N/A	Gutter X Slope (%)	N/A	
	Not i ound, Noo4.0.1		N/A	Painted X Walk1?	No	N/A	Painted X Walk2?	No	
All a deal and a second and	A A			X Walk 1 Direction	To W		X Walk 2 Direction	To S	
Contraction of the second second	1		N/A	X Walk 1 Width (in)	N/A	N/A	X Walk 2 Width (in)	N/A	
Street 1 Name E	INTRANCE			X Walk 1 Slope (%)	1.3		X Walk 2 Slope (%)	1.6	
Stop Condition-Street 2	StopSign			X Walk 1 X Slope (%)	1.0		X Walk 2 X Slope (%)	2.1	
1	(LAKE BV		N/A	Ramp inside XWalk1?	N/A	N/A	Ramp inside XWalk2?	N/A	
Stop Condition-Street 1	None			Road Slope (%)	0.2	N/A	Clear Space?	N/A	
				Road X Slope (%)	3.3	N/A	Clear Space to XWalk (in)	N/A

N/A	Any Obstructions?	0.0 N/A	N/A	Storm Grate/Utility Hazard?	N/A	
	Total Cost:	\$ 3200.00		Obstruction Type			Storm Grate/Utility Type		
					N/A			N/A
