Access Compliance Report

Public Rights-of-Way

(Curb Ramps)

Intersection ID: 51073	Main Street: RISBURG_LN	Cross Street: KEMPSFORD_DR	Location:	N
ADA ID: 13E7A22AFFB9	Ramp Type: PerpDiag	Initial Pass/Fail: Fail	Overall Compliance: No	Severity Score: 22.5
Codes/Mitigation Info/Possible Solution		Field Measurements/Component Compliance

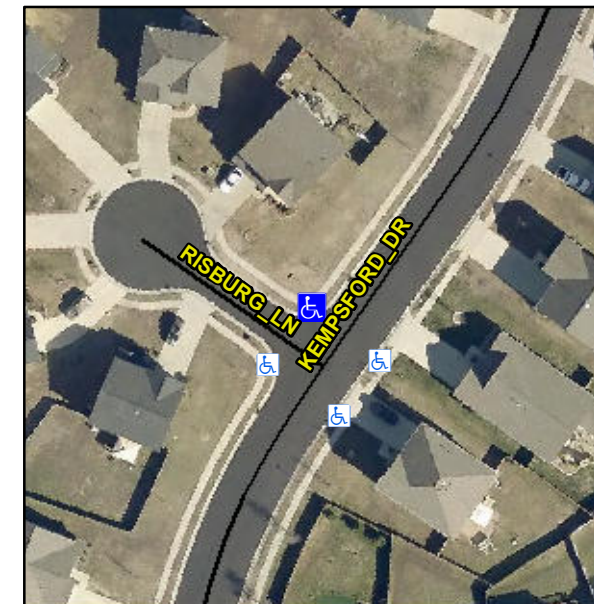
Not Found, R304.5.1, R304.2.2, R304.5.3

Compliance	Description	Data	Compliance	Description	Data
N/A	Ramp Length (in)	46.0	No	Ramp Slope (%)	10.2
No	Ramp Width (in)	36.0	No	Ramp XSlope (%)	3.3
N/A	Flare Type LT	N/A	N/A	Flare Type RT	N/A
N/A	Flare Slope LT (%)	N/A	N/A	Flare Slope RT (%)	N/A
N/A	Flare Traversable LT?	N/A	N/A	Flare Traversable RT?	N/A
N/A	Landing Length (in)	N/A	N/A	DWS Provided?	N/A
N/A	Landing Width (in)	N/A	N/A	DWS Contrast?	N/A
N/A	Landing Slope (%)	N/A	N/A	DWS Length (in)	N/A
N/A	Landing X Slope (%)	N/A	N/A	DWS Full Width?	N/A
N/A	Landing Curb? (Y/N)	N/A	N/A	DWS Offset (in)	N/A
N/A	Shared Landing?	N/A			
N/A	Gutter Ponding?	N/A	N/A	Gutter Slope (%)	N/A
N/A	Gutter Lip Ht (in)	N/A	N/A	Gutter X Slope (%)	N/A
N/A	Painted X Walk1?	No	N/A	Painted X Walk2?	No
	X Walk 1 Direction	To SW		X Walk 2 Direction	To SE
N/A	X Walk 1 Width (in)	N/A	N/A	X Walk 2 Width (in)	N/A
	X Walk 1 Slope (%)	3.4		X Walk 2 Slope (%)	1.3
	X Walk 1 X Slope (%)	1.0		X Walk 2 X Slope (%)	1.0

N/A	Ramp inside XWalk1?	N/A	N/A	Ramp inside XWalk2?	N/A
	Road Slope (%)	1.5	N/A	Clear Space?	N/A
	Road X Slope (%)	0.9	N/A	Clear Space to XWalk (in)	N/A
N/A	Any Obstructions?	N/A	N/A	Storm Grate/Utility Hazard?	N/A
	Obstruction Type			Storm Grate/Utility Type	
		N/A			N/A
			Yes	Surface Condition? (G/P)	Good

Remove & Replace Curb Ramp With Two New Directional Ramps or Equivalent.
