Access Compliance Report

Public Rights-of-Way

(Curb Ramps)

Intersection ID: 11486	Main Street: STRATFORD_AV	Cross Street: THE_PLAZA	Location: S
ADA ID: 13F1A4F55B86	Ramp Type: Perp	Initial Pass/Fail: Fail	Overall Compliance: No
		Severity Score: 25

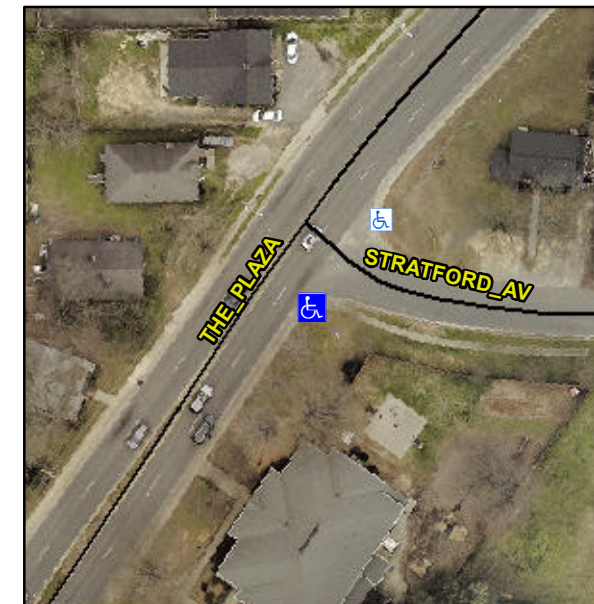
Compliance	Description	Data	Compliance	Description	Data
N/A	Ramp Length (in)	47.0	No	Ramp Slope (%)	11.2
Yes	Ramp Width (in)	48.0	No	Ramp XSlope (%)	6.4
N/A	Flare Type LT	N/A	N/A	Flare Type RT	N/A
N/A	Flare Slope LT (%)	N/A	N/A	Flare Slope RT (%)	N/A
N/A	Flare Traversable LT?	N/A	N/A	Flare Traversable RT?	N/A
N/A	Landing Length (in)	N/A	N/A	DWS Provided?	N/A
N/A	Landing Width (in)	N/A	N/A	DWS Contrast?	N/A
N/A	Landing Slope (%)	N/A	N/A	DWS Length (in)	N/A
N/A	Landing X Slope (%)	N/A	N/A	DWS Full Width?	N/A
N/A	Landing Curb? (Y/N)	N/A	N/A	DWS Offset (in)	N/A
N/A	Shared Landing?	N/A			
N/A	Gutter Ponding?	N/A	N/A	Gutter Slope (%)	N/A
N/A	Gutter Lip Ht (in)	N/A	N/A	Gutter X Slope (%)	N/A
N/A	Painted X Walk1?	No	N/A	Painted X Walk2?	N/A
	X Walk 1 Direction	To NE		X Walk 2 Direction	N/A
N/A	X Walk 1 Width (in)	N/A	N/A	X Walk 2 Width (in)	N/A
	X Walk 1 Slope (%)	4.2		X Walk 2 Slope (%)	N/A
	X Walk 1 X Slope (%)	2.5		X Walk 2 X Slope (%)	N/A

N/A	Ramp inside XWalk1?	N/A	N/A	Ramp inside XWalk2?	N/A
	Road Slope (%)	N/A	N/A	Clear Space?	N/A
	Road X Slope (%)	N/A	N/A	Clear Space to XWalk (in)	N/A
N/A	Any Obstructions?	N/A	N/A	Storm Grate/Utility Hazard?	N/A
	Obstruction Type			Storm Grate/Utility Type	
		N/A			N/A
			Yes	Surface Condition? (G/P)	Good

Possible Solutions:

Remove & Replace Entire Ramp.

PROW/ADA:

R304.2.2, R304.5.3
