Access Compliance Report

Public Rights-of-Way

(Curb Ramps)

Intersection ID: 8925	Main Street: E_W_T_HARRIS_BV	Cross Street: THE_PLAZA	Location: NW
ADA ID: 13FA8699FF58	Ramp Type: Directional1	Initial Pass/Fail: Pass	Overall Compliance: No
Severity Score: 0			
Codes/Mitigation Info/Possible Solution		Field Measurements/Component Compliance

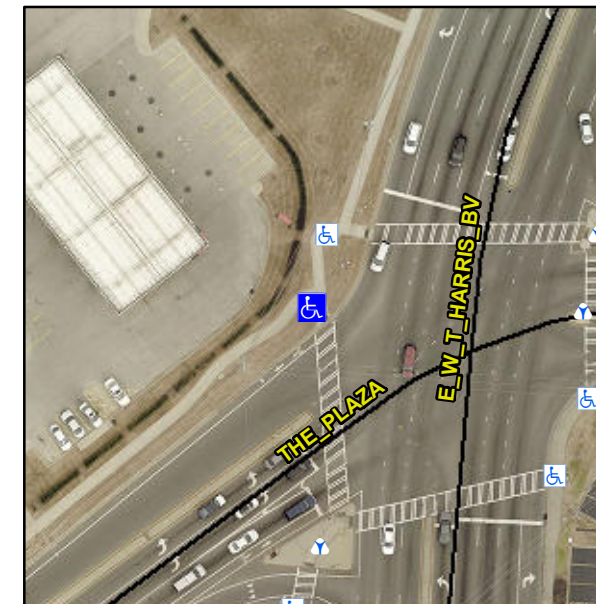
Compliance	Description	Data	Compliance	Description	Data
N/A	Ramp Length (in)	83.0	Yes	Grade Break?	Yes
Yes	Ramp Width (in)	71.0	No	Grade Break Slope (%)	6.4
Yes	Ramp Slope (%)	8.2	Yes	Grade Break XSlope (%)	1.2
Yes	Ramp XSlope (%)	0.3			
Yes	Flare Type LT	N/A	Yes	Flare Type RT	N/A
N/A	Flare Slope LT (%)	N/A	N/A	Flare Slope RT (%)	N/A
N/A	Flare Traversable LT?	No	N/A	Flare Traversable RT?	No
Yes	Landing Length (in)	60.0	Yes	DWS Provided?	Yes
Yes	Landing Width (in)	72.0	Yes	DWS Contrast?	Yes
No	Landing Slope (%)	2.1	Yes	DWS Length (in)	24.0
Yes	Landing X Slope (%)	0.6	Yes	DWS Full Width?	Yes
N/A	Landing Curb? (Y/N)	N/A	Yes	DWS Offset LT (in)	32.0
N/A	Shared Landing?	No	Yes	DWS Offset RT (in)	0.0
No	Gutter Ponding?	Yes	Yes	Gutter Slope (%)	3.3
Yes	Gutter Lip Ht (in)	0.0	No	Gutter X Slope (%)	3.2
N/A	Painted X Walk1?	Yes		Road Slope (%)	2.2
	X Walk 1 Direction	To S		Road X Slope (%)	2.4
	X Walk 1 Width (in)	134.0		Clear Space?	Yes

X Walk 1 Slope (%)	2.2	N/A	Clear Space to XWalk (in)	N/A
	X Walk 1 X Slope (%)	2.4	Yes	Storm Grate/Utility Hazard?	No
Yes	Ramp inside XWalk1?	Yes		Storm Grate/Utility Type	
Yes	Any Obstructions?	No			N/A
	Obstruction Type		Yes	Surface Condition? (G/P)	Good
			N/A	Curb Slope (%)	6.1

Possible Solutions:

**Remove & Replace Entire Ramp.
Remove & Replace Gutter.**

**R304.2.2-Perp, R304.3.2-Para,
R304.5.3, R302.7**
