Access Compliance Report

Public Rights-of-Way

(Curb Ramps)

Intersection ID: N/A	Main Street: LANGWELL_LN	Cross Street: HAMILTON_BRIDGE_RD	Location: SW
ADA ID: 13FB09D8F4A0	Ramp Type: Perp	Initial Pass/Fail: Fail	Overall Compliance: No
Severity Score: 22.5			
Codes/Mitigation Info/Possible Solution		Field Measurements/Component Compliance

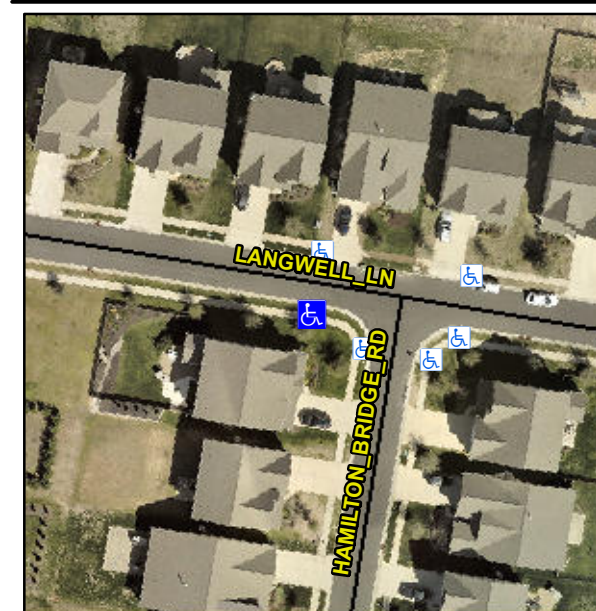
Not Found, R304.5.1, R304.2.2, R304.5.3

Compliance	Description	Data	Compliance	Description	Data
N/A	Ramp Length (in)	48.0	No	Ramp Slope (%)	10.1
No	Ramp Width (in)	46.5	No	Ramp XSlope (%)	2.2
N/A	Flare Type LT	N/A	N/A	Flare Type RT	N/A
N/A	Flare Slope LT (%)	N/A	N/A	Flare Slope RT (%)	N/A
N/A	Flare Traversable LT?	N/A	N/A	Flare Traversable RT?	N/A
N/A	Landing Length (in)	N/A	N/A	DWS Provided?	N/A
N/A	Landing Width (in)	N/A	N/A	DWS Contrast?	N/A
N/A	Landing Slope (%)	N/A	N/A	DWS Length (in)	N/A
N/A	Landing X Slope (%)	N/A	N/A	DWS Full Width?	N/A
N/A	Landing Curb? (Y/N)	N/A	N/A	DWS Offset (in)	N/A
N/A	Shared Landing?	N/A			
N/A	Gutter Ponding?	N/A	N/A	Gutter Slope (%)	N/A
N/A	Gutter Lip Ht (in)	1.0	N/A	Gutter X Slope (%)	N/A
N/A	Painted X Walk1?	No	N/A	Painted X Walk2?	N/A
	X Walk 1 Direction	To NE		X Walk 2 Direction	N/A
N/A	X Walk 1 Width (in)	N/A	N/A	X Walk 2 Width (in)	N/A
	X Walk 1 Slope (%)	0.3		X Walk 2 Slope (%)	N/A
	X Walk 1 X Slope (%)	2.0		X Walk 2 X Slope (%)	N/A

Remove & Replace Entire Ramp.

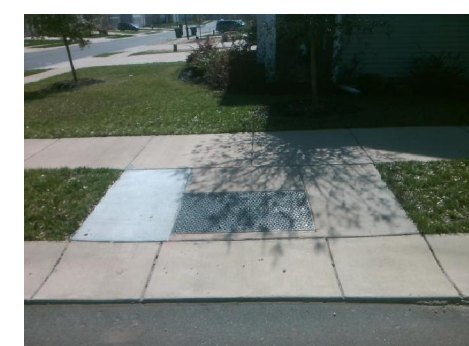
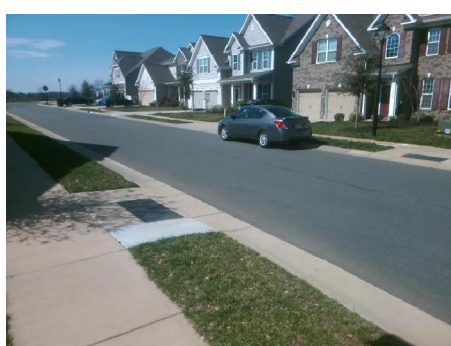
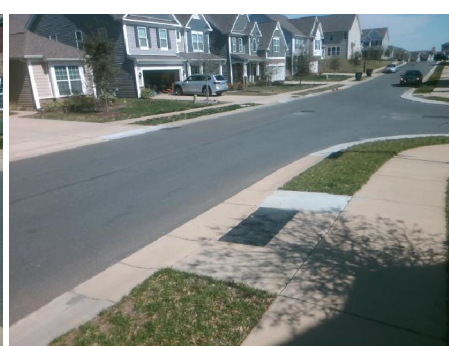
N/A	Ramp inside XWalk1?	N/A	N/A	Ramp inside XWalk2?	N/A
	Road Slope (%)	N/A	N/A	Clear Space?	N/A
	Road X Slope (%)	N/A	N/A	Clear Space to XWalk (in)	N/A
N/A	Any Obstructions?	N/A	N/A	Storm Grate/Utility Hazard?	N/A
	Obstruction Type			Storm Grate/Utility Type	
		N/A			N/A
			Yes	Surface Condition? (G/P)	Good
