Access Compliance Report Public Rights-of-Way (Curb Ramps)

Intersection ID: 3215 Main Street: BELLMORE_CT Cross Street: OLD_BRIDGE_LN Location: S

ADA ID: 14092D28A1BA **Overall Compliance: No Severity Score:** Ramp Type: Perp Initial Pass/Fail: Pass

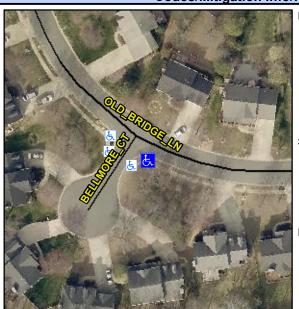
Comp	liance Description	Data			Description	Data
N/A	Ramp Length (in)	48.0	Yes	Ramp	Slope (%)	5.4
Yes	Ramp Width (in)	48.0	Yes	Ramp	XSlope (%)	1.6
N/A	Flare Type LT	Sloped	N/A	Flare	Type RT	N/A
N/A	Flare Slope LT (%)	2.2	N/A	Flare	Slope RT (%)	1.8
N/A	Flare Traversable LT?	No	N/A	Flare	Traversable RT?	No
No	Landing Length (in)	47.0	Yes	DWS	Provided?	Yes
Yes	Landing Width (in)	48.0	Yes	DWS	Contrast?	Yes
Yes	Landing Slope (%)	1.6	Yes	DWS	Length (in)	25.5
No	Landing X Slope (%)	2.4	Yes	DWS	Full Width?	Yes
N/A	Landing Curb? (Y/N)	No	No	DWS	Offset (in)	3.0
N/A	Shared Landing?	No				
Yes	Gutter Ponding?	No	Yes	Gutte	r Slope (%)	0.9
Yes	Gutter Lip Ht (in)	0.0	Yes	Gutte	r X Slope (%)	1.2
N/A	Painted X Walk1?	No	N/A	Paint	ed X Walk2?	N/A
	X Walk 1 Direction	To NE		X Wa	lk 2 Direction	N/A
N/A	X Walk 1 Width (in)	N/A	N/A	X Wa	lk 2 Width (in)	N/A
	X Walk 1 Slope (%)	9.9		X Wa	lk 2 Slope (%)	N/A
	X Walk 1 X Slope (%)	1.7		X Wa	lk 2 X Slope (%)	N/A

N/A	Ramp inside XWalk1?	N/A	N/A	Ram	inside XWalk2?	N/A
	Road Slope (%)	N/A	N/A	Clear	Space?	Yes
	Road X Slope (%)	N/A	N/A	Clear	Space to XWalk (in)	N/A
Yes	Any Obstructions?	No	Yes	Storn	n Grate/Utility Hazard?	No
	Obstruction Type			Storn	n Grate/Utility Type	
		N/A				N/A
			Yes	Surfa	ce Condition? (G/P)	Good
WELL

rossible solution						
Possible Solutions:						
Remove & Replace Entire Ramp.						
Surveyor Notes:						
N/A						
DDC/M/ADA						
PROW/ADA:						
Not Found, R304.2.1, R304.5.3, R305.2						
R305.2
