Access Compliance Report

Public Rights-of-Way

(Curb Ramps)

Intersection ID: 23966	Main Street: CAROLINA PAVILION DR_N	Cross Street: SOUTH BV	Location: NW
ADA ID: 140EB20CA469	Ramp Type: Perp	Initial Pass/Fail: Fail	Overall Compliance: No
Severity Score: 25			
Codes/Mitigation Info/Possible Solution		Field Measurements/Component Compliance

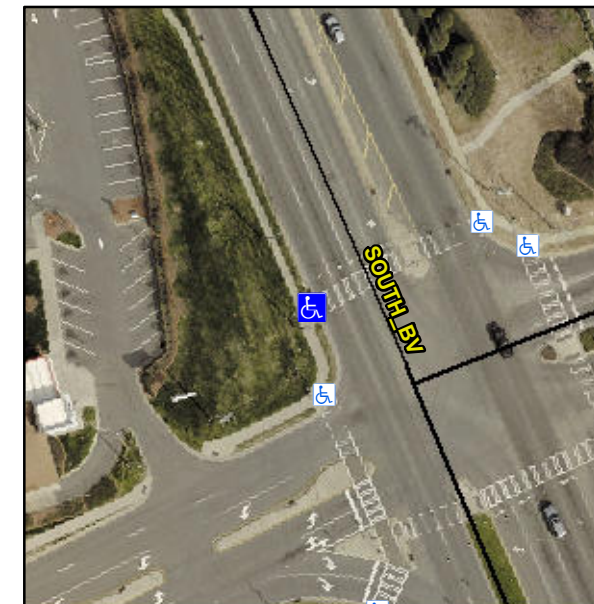
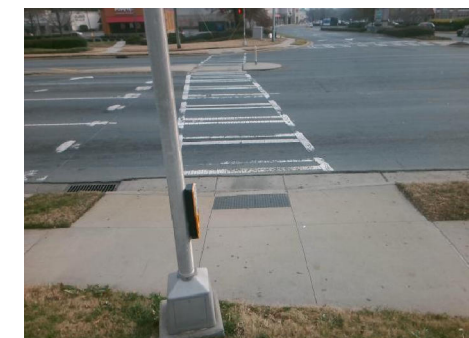
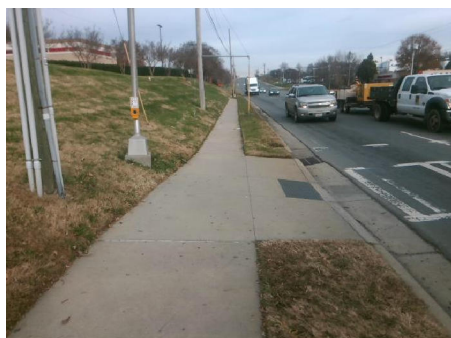
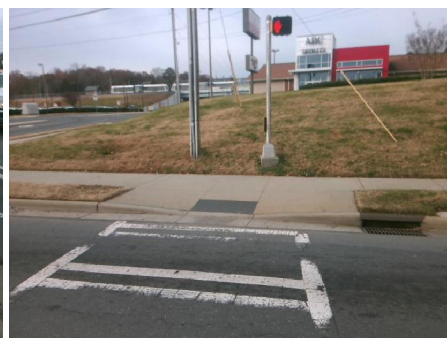
Not Found, R304.2.2

Compliance	Description	Data	Compliance	Description	Data
N/A	Ramp Length (in)	47.0	No	Ramp Slope (%)	13.9
Yes	Ramp Width (in)	48.0	Yes	Ramp XSlope (%)	0.6
N/A	Flare Type LT	N/A	N/A	Flare Type RT	N/A
N/A	Flare Slope LT (%)	N/A	N/A	Flare Slope RT (%)	N/A
N/A	Flare Traversable LT?	N/A	N/A	Flare Traversable RT?	N/A
N/A	Landing Length (in)	N/A	N/A	DWS Provided?	N/A
N/A	Landing Width (in)	N/A	N/A	DWS Contrast?	N/A
N/A	Landing Slope (%)	N/A	N/A	DWS Length (in)	N/A
N/A	Landing X Slope (%)	N/A	N/A	DWS Full Width?	N/A
N/A	Landing Curb? (Y/N)	N/A	N/A	DWS Offset (in)	N/A
N/A	Shared Landing?	N/A			
N/A	Gutter Ponding?	N/A	N/A	Gutter Slope (%)	N/A
N/A	Gutter Lip Ht (in)	N/A	N/A	Gutter X Slope (%)	N/A
N/A	Painted X Walk1?	Yes	N/A	Painted X Walk2?	N/A
	X Walk 1 Direction	To E		X Walk 2 Direction	N/A
N/A	X Walk 1 Width (in)	112.0	N/A	X Walk 2 Width (in)	N/A
	X Walk 1 Slope (%)	2.3		X Walk 2 Slope (%)	N/A
	X Walk 1 X Slope (%)	0.3		X Walk 2 X Slope (%)	N/A

N/A	Ramp inside XWalk1?	Yes	N/A	Ramp inside XWalk2?	N/A
	Road Slope (%)	N/A	N/A	Clear Space?	N/A
	Road X Slope (%)	N/A	N/A	Clear Space to XWalk (in)	N/A
N/A	Any Obstructions?	N/A	N/A	Storm Grate/Utility Hazard?	N/A
	Obstruction Type			Storm Grate/Utility Type	
		N/A			N/A
		Yes		Surface Condition? (G/P)	Good

Remove & Replace Entire Ramp.
