# Access Compliance Report

## Public Rights-of-Way

### (Curb Ramps)

Intersection ID: 4700	Main Street: BELLA_VISTA_CT	Cross Street: FREE_BIRD_AV	Location: SW
ADA ID: 141E11F3ACAC	Ramp Type: Perp	Initial Pass/Fail: Fail	Overall Compliance: No
Severity Score: 36.25			
Codes/Mitigation Info/Possible Solution		Field Measurements/Component Compliance

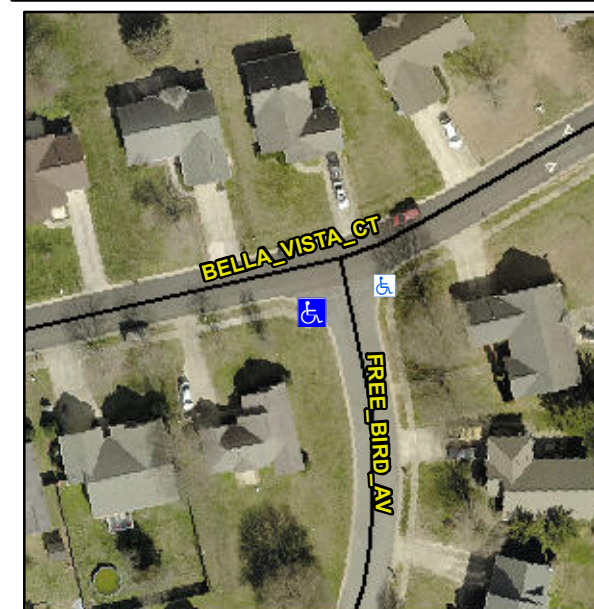
**Not Found, R304.5.1, R304.5.3**

Compliance	Description	Data	Compliance	Description	Data
N/A	Ramp Length (in)	48.0	Yes	Ramp Slope (%)	5.7
No	Ramp Width (in)	30.0	No	Ramp XSlope (%)	4.6
N/A	Flare Type LT	N/A	N/A	Flare Type RT	N/A
N/A	Flare Slope LT (%)	N/A	N/A	Flare Slope RT (%)	N/A
N/A	Flare Traversable LT?	N/A	N/A	Flare Traversable RT?	N/A
N/A	Landing Length (in)	N/A	N/A	DWS Provided?	N/A
N/A	Landing Width (in)	N/A	N/A	DWS Contrast?	N/A
N/A	Landing Slope (%)	N/A	N/A	DWS Length (in)	N/A
N/A	Landing X Slope (%)	N/A	N/A	DWS Full Width?	N/A
N/A	Landing Curb? (Y/N)	N/A	N/A	DWS Offset (in)	N/A
N/A	Shared Landing?	N/A			
N/A	Gutter Ponding?	N/A	N/A	Gutter Slope (%)	N/A
N/A	Gutter Lip Ht (in)	N/A	N/A	Gutter X Slope (%)	N/A
N/A	Painted X Walk1?	No	N/A	Painted X Walk2?	N/A
	X Walk 1 Direction	To E		X Walk 2 Direction	N/A
N/A	X Walk 1 Width (in)	N/A	N/A	X Walk 2 Width (in)	N/A
	X Walk 1 Slope (%)	1.5		X Walk 2 Slope (%)	N/A
	X Walk 1 X Slope (%)	3.1		X Walk 2 X Slope (%)	N/A

N/A	Ramp inside XWalk1?	N/A	N/A	Ramp inside XWalk2?	N/A
	Road Slope (%)	N/A	N/A	Clear Space?	N/A
	Road X Slope (%)	N/A	N/A	Clear Space to XWalk (in)	N/A
N/A	Any Obstructions?	N/A	N/A	Storm Grate/Utility Hazard?	N/A
	Obstruction Type			Storm Grate/Utility Type	
		N/A			N/A
			Yes	Surface Condition? (G/P)	Good

**Remove & Replace Entire Ramp.**

Total Cost: \$ 1850.00
