Access Compliance Report

Public Rights-of-Way

(Curb Ramps)

| Intersection ID: 28536 | Main Street: SOUTH_STREAM_BV | Cross Street: W_TYVOLA_RD | Location: S |

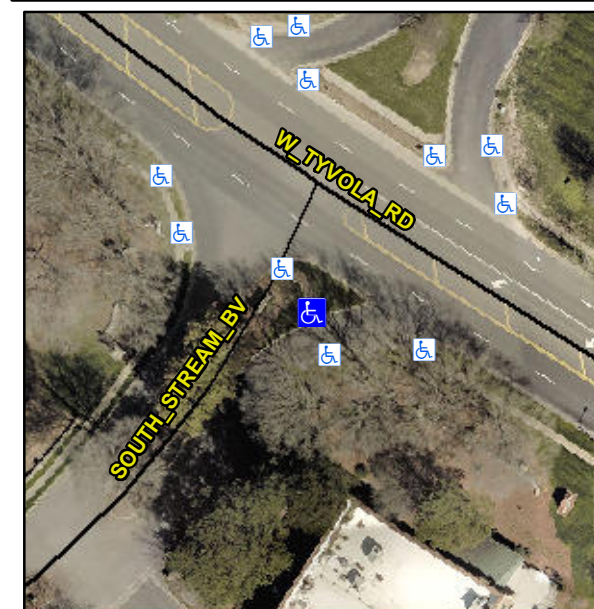
| ADA ID: 142DBE3512AF | Ramp Type: MedianPerp | Initial Pass/Fail: Fail | Overall Compliance: No |
| Severity Score: 1.25 | | | |

Not Found, R304.5.3

| Compliance | Description | Data | Compliance | Description | Data |
|---|---|---|---|---|---|
| Yes | Ramp Width (in) | 51.0 | No | Ramp XSlope (%) | 3.5 |

Possible Solutions:

Remove & Replace Entire Ramp.

Total Cost: \$ 1650.00
