Access Compliance Report

Public Rights-of-Way

(Curb Ramps)

Intersection ID: N/A	Main Street: BROOKSIDE_LN	Cross Street: N/A	Location: SW
ADA ID: 146B7C273837	Ramp Type: Directional	Initial Pass/Fail: Fail	Overall Compliance: No
		Severity Score: 1.25

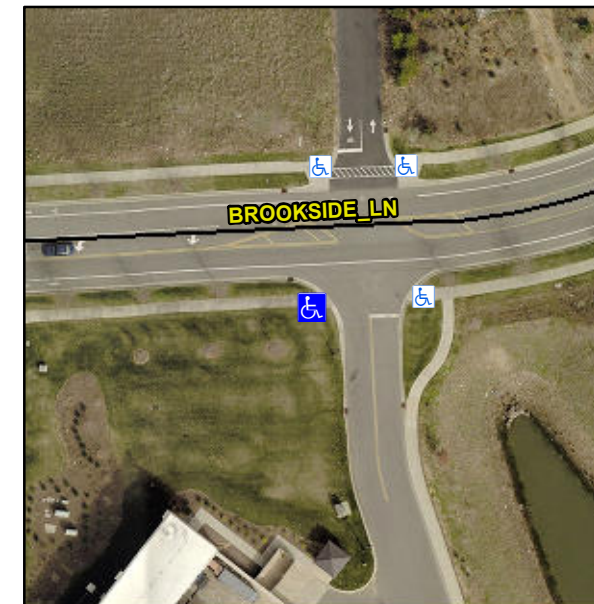
R304.5.3

Compliance	Description	Data	Compliance	Description	Data
N/A	Ramp Length (in)	119.0	N/A	Grade Break?	N/A
Yes	Ramp Width (in)	71.0	N/A	Grade Break Slope (%)	0.0
Yes	Ramp Slope (%)	7.3	N/A	Grade Break XSlope (%)	0.0
No	Ramp XSlope (%)	3.8			
N/A	Flare Type LT	N/A	N/A	Flare Type RT	N/A
N/A	Flare Slope LT (%)	N/A	N/A	Flare Slope RT (%)	0.0
N/A	Flare Traversable LT?	N/A	N/A	Flare Traversable RT?	N/A
N/A	Landing Length (in)	0.0	N/A	DWS Provided?	N/A
N/A	Landing Width (in)	0.0	N/A	DWS Contrast?	N/A
N/A	Landing Slope (%)	0.0	N/A	DWS Length (in)	N/A
N/A	Landing X Slope (%)	0.0	N/A	DWS Full Width?	N/A
N/A	Landing Curb? (Y/N)	N/A	N/A	DWS Offset LT (in)	N/A
N/A	Shared Landing?	N/A	N/A	DWS Offset RT (in)	N/A
N/A	Gutter Ponding?	0.0	N/A	Gutter Slope (%)	N/A
N/A	Gutter Lip Ht (in)	0.0	N/A	Gutter X Slope (%)	N/A
N/A	Painted X Walk1?	No		Road Slope (%)	1.7
	X Walk 1 Direction	To NE		Road X Slope (%)	1.2
	X Walk 1 Width (in)	N/A		Clear Space?	N/A

X Walk 1 Slope (%)	1.7	N/A	Clear Space to XWalk (in)	N/A
	X Walk 1 X Slope (%)	1.2	N/A	Storm Grate/Utility Hazard?	N/A
N/A	Ramp inside XWalk1?	N/A		Storm Grate/Utility Type	
N/A	Any Obstructions?	N/A			N/A
	Obstruction Type		Yes	Surface Condition? (G/P)	Good
			N/A	Curb Slope (%)	7.9

Possible Solutions:

Remove & Replace Entire Ramp.
