# Access Compliance Report

## Public Rights-of-Way

### (Curb Ramps)

Intersection ID: 17126	Main Street: MISSION_HILLS_RD	Cross Street: TEABERRY_CT	Location: NW
ADA ID: 147070C9BA96	Ramp Type: PerpDiag	Initial Pass/Fail: Fail	Overall Compliance: No
Codes/Mitigation Info/Possible Solution		Field Measurements/Component Compliance	
Severity Score: 12.5

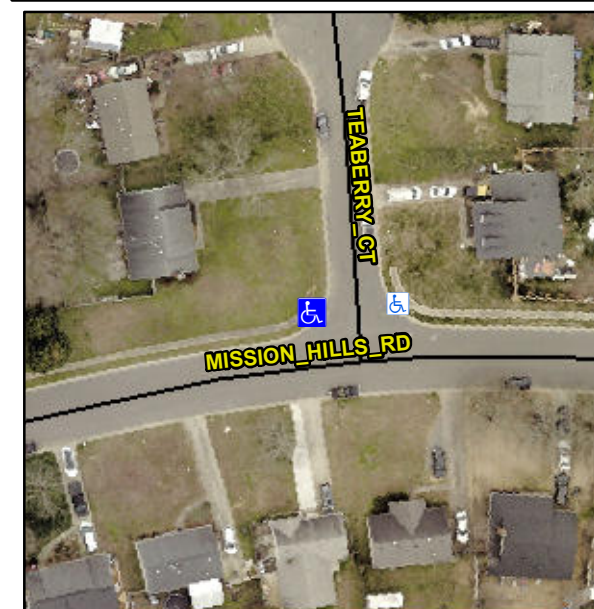
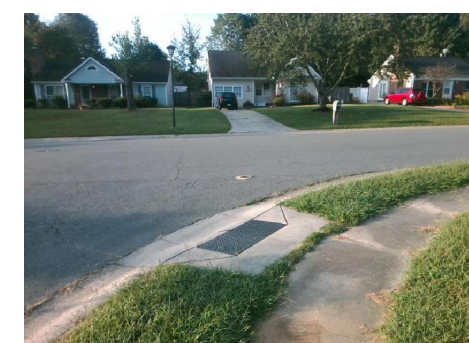
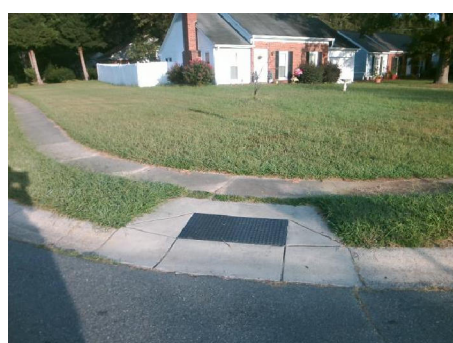
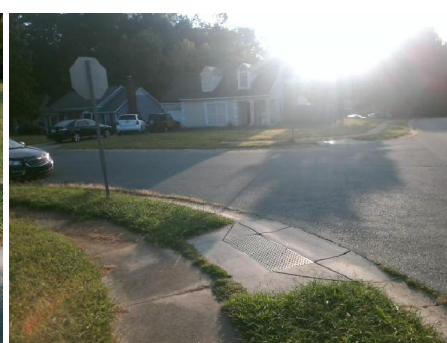
**Not Found, R304.2.2**

Compliance	Description	Data	Compliance	Description	Data
N/A	Ramp Length (in)	48.0	No	Ramp Slope (%)	9.0
Yes	Ramp Width (in)	48.0	Yes	Ramp XSlope (%)	1.9
N/A	Flare Type LT	N/A	N/A	Flare Type RT	N/A
N/A	Flare Slope LT (%)	N/A	N/A	Flare Slope RT (%)	N/A
N/A	Flare Traversable LT?	N/A	N/A	Flare Traversable RT?	N/A
N/A	Landing Length (in)	N/A	N/A	DWS Provided?	N/A
N/A	Landing Width (in)	N/A	N/A	DWS Contrast?	N/A
N/A	Landing Slope (%)	N/A	N/A	DWS Length (in)	N/A
N/A	Landing X Slope (%)	N/A	N/A	DWS Full Width?	N/A
N/A	Landing Curb? (Y/N)	N/A	N/A	DWS Offset (in)	N/A
N/A	Shared Landing?	N/A			
N/A	Gutter Ponding?	N/A	N/A	Gutter Slope (%)	N/A
N/A	Gutter Lip Ht (in)	N/A	N/A	Gutter X Slope (%)	N/A
N/A	Painted X Walk1?	No	N/A	Painted X Walk2?	No
	X Walk 1 Direction	To S		X Walk 2 Direction	To E
N/A	X Walk 1 Width (in)	N/A	N/A	X Walk 2 Width (in)	N/A
	X Walk 1 Slope (%)	1.9		X Walk 2 Slope (%)	1.1
	X Walk 1 X Slope (%)	1.0		X Walk 2 X Slope (%)	0.5

N/A	Ramp inside XWalk1?	N/A	N/A	Ramp inside XWalk2?	N/A
	Road Slope (%)	1.9	N/A	Clear Space?	N/A
	Road X Slope (%)	0.1	N/A	Clear Space to XWalk (in)	N/A
N/A	Any Obstructions?	N/A	N/A	Storm Grate/Utility Hazard?	N/A
	Obstruction Type			Storm Grate/Utility Type	
		N/A			N/A
		Yes		Surface Condition? (G/P)	Good

**Remove & Replace Curb Ramp With Two New Directional Ramps or Equivalent.**
