Access Compliance Report

Public Rights-of-Way (Curb Ramps)

Intersection ID: N/A	Main Street: CRAIGHEAD_RD	Cross Street: N/A	Location: NW
ADA ID: 1475A3E4A0E8	Ramp Type: PerpDiag	Initial Pass/Fail: Fail	Overall Compliance: No
Codes/Mitigation Info/Possible Solution		Field Measurements/Component Compliance

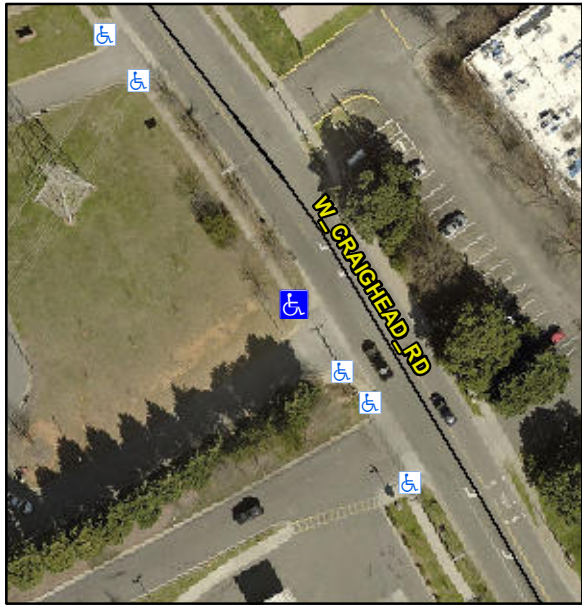
Compliance	Description	Data	Compliance	Description	Data
N/A	Ramp Length (in)	151.0	No	Ramp Slope (%)	12.5
Yes	Ramp Width (in)	60.0	Yes	Ramp XSlope (%)	3.8
N/A	Flare Type LT	N/A	N/A	Flare Type RT	N/A
N/A	Flare Slope LT (%)	N/A	N/A	Flare Slope RT (%)	N/A
N/A	Flare Traversable LT?	N/A	N/A	Flare Traversable RT?	N/A
N/A	Landing Length (in)	N/A	N/A	DWS Provided?	N/A
N/A	Landing Width (in)	N/A	N/A	DWS Contrast?	N/A
N/A	Landing Slope (%)	N/A	N/A	DWS Length (in)	N/A
N/A	Landing X Slope (%)	N/A	N/A	DWS Full Width?	N/A
N/A	Landing Curb? (Y/N)	N/A	N/A	DWS Offset (in)	N/A
N/A	Shared Landing?	N/A			
N/A	Gutter Ponding?	N/A	N/A	Gutter Slope (%)	N/A
N/A	Gutter Lip Ht (in)	N/A	N/A	Gutter X Slope (%)	N/A
N/A	Painted X Walk1?	No	N/A	Painted X Walk2?	No
	X Walk 1 Direction	To S		X Walk 2 Direction	To E
N/A	X Walk 1 Width (in)	N/A	N/A	X Walk 2 Width (in)	N/A
	X Walk 1 Slope (%)	2.3		X Walk 2 Slope (%)	4.6
	X Walk 1 X Slope (%)	3.8		X Walk 2 X Slope (%)	3.1

N/A	Ramp inside XWalk1?	N/A	N/A	Ramp inside XWalk2?	N/A
	Road Slope (%)	4.5	N/A	Clear Space?	N/A
	Road X Slope (%)	0.8	N/A	Clear Space to XWalk (in)	N/A
N/A	Any Obstructions?	N/A	N/A	Storm Grate/Utility Hazard?	N/A
	Obstruction Type			Storm Grate/Utility Type	
		N/A			N/A
			No	Surface Condition? (G/P)	Poor

Possible Solutions:

Remove & Replace Curb Ramp With Two New Directional Ramps or Equivalent.
