# Access Compliance Report

## Public Rights-of-Way

### (Curb Ramps)

| Intersection ID: 31619 | Main Street: DEREK CHRISTOPHER CT | Cross Street: MARIA CHRISTINA LN | Location: NW |

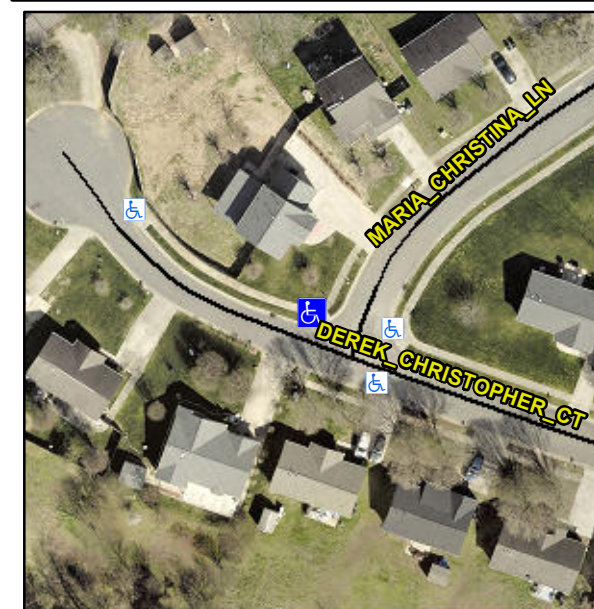
| ADA ID: 147B8C524A0D | Ramp Type: BlendTrans1 | Initial Pass/Fail: Fail | Overall Compliance: No |
| Severity Score: 10 | | | |

**Not Found, R304.5.1, R304.5.3**

| Compliance | Description | Data | Compliance | Description | Data |
|---|---|---|---|---|---|
| No | Ramp Width (in) | 39.5 | No | BlendTrans XSlope (%) | 2.8 |

**Remove & Replace Curb Ramp With Two New Directional Ramps or Equivalent.**

Total Cost: \$ 3200.00
