Access Compliance Report

Public Rights-of-Way

(Curb Ramps)

Intersection ID: 12164	Main Street: SEIGLE_AV	Cross Street: BELMONT_AV	Location: S
ADA ID: 1487AD6AFB67	Ramp Type: Perp	Initial Pass/Fail: Fail	Overall Compliance: No
Severity Score: 37.5			
Codes/Mitigation Info/Possible Solution		Field Measurements/Component Compliance

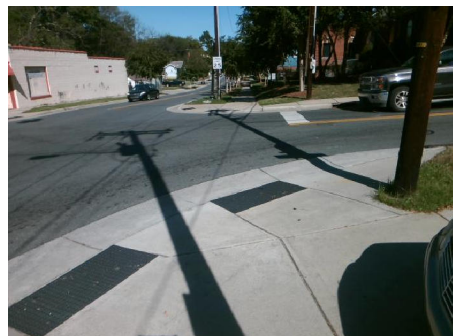
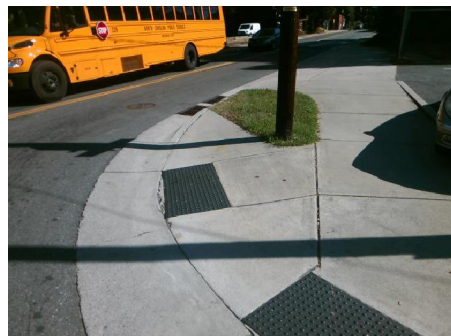
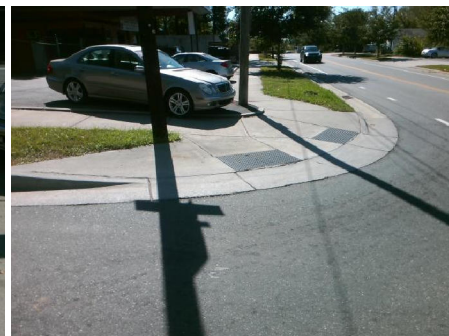
Compliance	Description	Data	Compliance	Description	Data
N/A	Ramp Length (in)	60.0	No	Ramp Slope (%)	8.9
Yes	Ramp Width (in)	48.0	No	Ramp XSlope (%)	7.2
N/A	Flare Type LT	N/A	N/A	Flare Type RT	N/A
N/A	Flare Slope LT (%)	N/A	N/A	Flare Slope RT (%)	N/A
N/A	Flare Traversable LT?	N/A	N/A	Flare Traversable RT?	N/A
N/A	Landing Length (in)	N/A	N/A	DWS Provided?	N/A
N/A	Landing Width (in)	N/A	N/A	DWS Contrast?	N/A
N/A	Landing Slope (%)	N/A	N/A	DWS Length (in)	N/A
N/A	Landing X Slope (%)	N/A	N/A	DWS Full Width?	N/A
N/A	Landing Curb? (Y/N)	N/A	N/A	DWS Offset (in)	N/A
N/A	Shared Landing?	N/A			
N/A	Gutter Ponding?	N/A	N/A	Gutter Slope (%)	N/A
N/A	Gutter Lip Ht (in)	0.5	N/A	Gutter X Slope (%)	N/A
N/A	Painted X Walk1?	No	N/A	Painted X Walk2?	N/A
	X Walk 1 Direction	To NE		X Walk 2 Direction	N/A
N/A	X Walk 1 Width (in)	N/A	N/A	X Walk 2 Width (in)	N/A
	X Walk 1 Slope (%)	0.3		X Walk 2 Slope (%)	N/A
	X Walk 1 X Slope (%)	6.6		X Walk 2 X Slope (%)	N/A

N/A	Ramp inside XWalk1?	N/A	N/A	Ramp inside XWalk2?	N/A
	Road Slope (%)	N/A	N/A	Clear Space?	N/A
	Road X Slope (%)	N/A	N/A	Clear Space to XWalk (in)	N/A
N/A	Any Obstructions?	N/A	N/A	Storm Grate/Utility Hazard?	N/A
	Obstruction Type			Storm Grate/Utility Type	
		N/A			N/A
			Yes	Surface Condition? (G/P)	Good

Possible Solutions:

Remove & Replace Entire Ramp.
