Access Compliance Report Public Rights-of-Way (Curb Ramps)

Intersection ID: 52800 Main Street: CHARMECK_PALISADES_DR Cross Street: CARNEGIE_BV Location: SE **Overall Compliance: No** ADA ID: 1491249382A6 Ramp Type: Directional1 Initial Pass/Fail: Fail **Severity Score:** 25

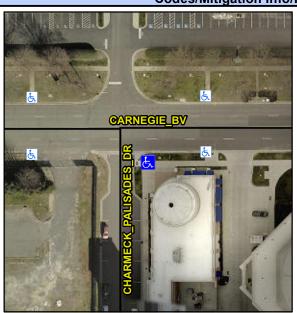
Field Measurements/Component Compliance								
Compli	ance Description	Data	Compl	iance Description	Data			
N/A	Ramp Length (in)	69.0	N/A	Grade Break?	N/A			
Yes	Ramp Width (in)	63.0	N/A	Grade Break Slope (%)	0.0			
No	Ramp Slope (%)	9.5	N/A	Grade Break XSlope (%)	0.0			
No	Ramp XSlope (%)	5.8						
N/A	Flare Type LT	N/A	N/A	Flare Type RT	N/A			
N/A	Flare Slope LT (%)	N/A	N/A	Flare Slope RT (%)	0.0			
N/A	Flare Traversable LT?	N/A	N/A	Flare Traversable RT?	N/A			
N/A	Landing Length (in)	0.0	N/A	DWS Provided?	N/A			
N/A	Landing Width (in)	0.0	N/A	DWS Contrast?	N/A			
N/A	Landing Slope (%)	0.0	N/A	DWS Length (in)	N/A			
N/A	Landing X Slope (%)	0.0	N/A	DWS Full Width?	N/A			
N/A	Landing Curb? (Y/N)	N/A	N/A	DWS Offset LT (in)	N/A			
N/A	Shared Landing?	N/A	N/A	DWS Offset RT (in)	N/A			
N/A	Gutter Ponding?	0.0	N/A	Gutter Slope (%)	N/A			
N/A	Gutter Lip Ht (in)	0.0	N/A	Gutter X Slope (%)	N/A			
N/A	Painted X Walk1?	No		Road Slope (%)	0.7

Possible Solutions: Remove & Replace Entire Ramp. Surveyor Notes: N/A PROW/ADA: R304.2.2, R304.5.3
