# Access Compliance Report

## Public Rights-of-Way (Curb Ramps)

| Intersection ID: 45705 | Main Street: CALDWELL_RIDGE_PY | Cross Street: N/A | Location: NW |
| ADA ID: 149D031BBE32 | Ramp Type: Perp | Initial Pass/Fail: Fail | Overall Compliance: No |

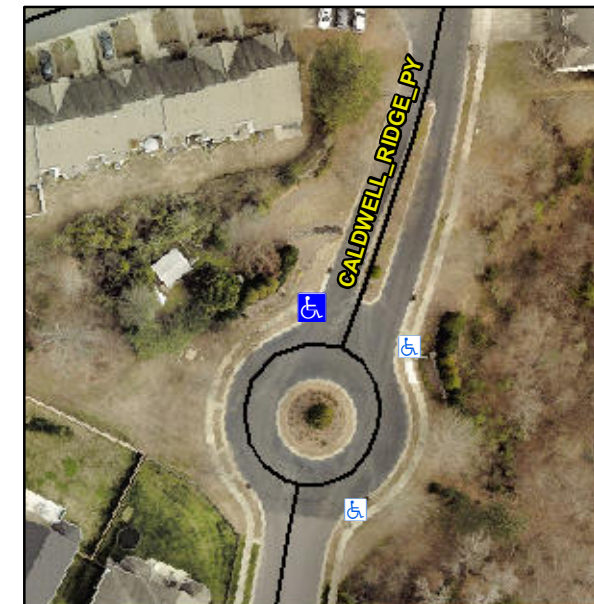
| | | Severity Score: 22.5 | |

**Not Found, R304.5.1, R304.2.2**

| Compliance | Description | Data | Compliance | Description | Data |
|---|---|---|---|---|---|
| N/A | Ramp Length (in) | 47.0 | No | Ramp Slope (%) | 10.6 |
| No | Ramp Width (in) | 42.5 | Yes | Ramp XSlope (%) | 2.7 |

**Remove & Replace Entire Ramp.**

Total Cost: \$ 1850.00
