# Access Compliance Report

## Public Rights-of-Way

### (Curb Ramps)

Intersection ID: 26384	Main Street: BEVINGTON_PL	Cross Street: ELM_LN	Location: NW
ADA ID: 149E0DEDFDFC	Ramp Type: PerpDiag	Initial Pass/Fail: Fail	Overall Compliance: No
		Severity Score: 25

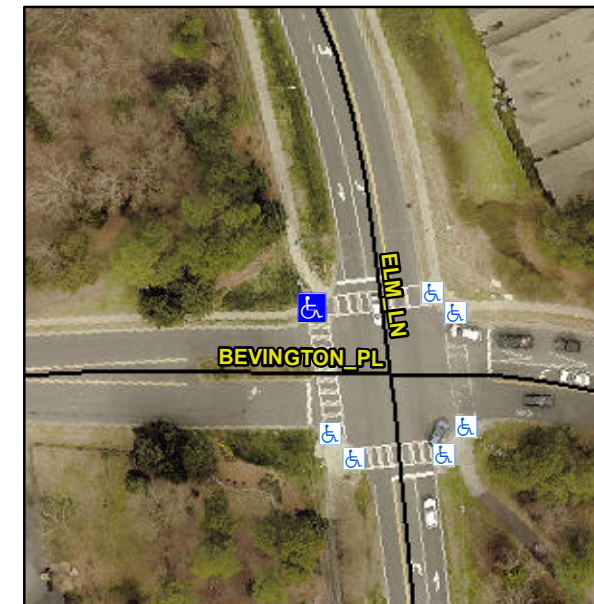
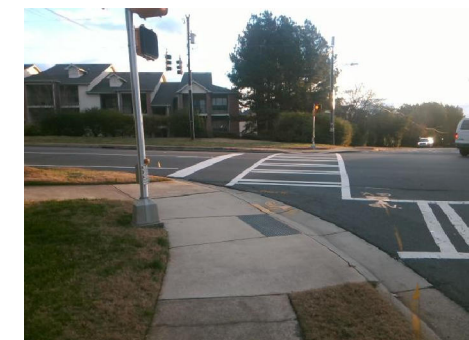
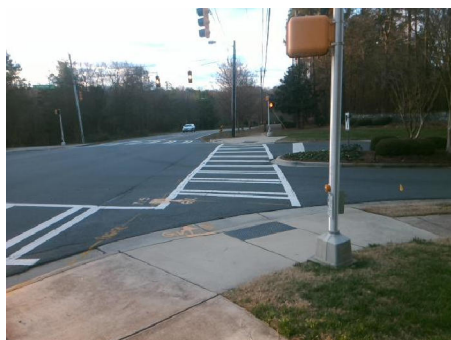
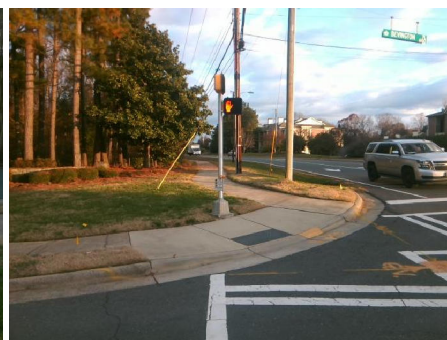
**Not Found, R304.2.2, R304.5.3**

Compliance	Description	Data	Compliance	Description	Data
N/A	Ramp Length (in)	80.0	No	Ramp Slope (%)	8.7
Yes	Ramp Width (in)	48.0	No	Ramp XSlope (%)	6.7
N/A	Flare Type LT	N/A	N/A	Flare Type RT	N/A
N/A	Flare Slope LT (%)	N/A	N/A	Flare Slope RT (%)	N/A
N/A	Flare Traversable LT?	N/A	N/A	Flare Traversable RT?	N/A
N/A	Landing Length (in)	N/A	N/A	DWS Provided?	N/A
N/A	Landing Width (in)	N/A	N/A	DWS Contrast?	N/A
N/A	Landing Slope (%)	N/A	N/A	DWS Length (in)	N/A
N/A	Landing X Slope (%)	N/A	N/A	DWS Full Width?	N/A
N/A	Landing Curb? (Y/N)	N/A	N/A	DWS Offset (in)	N/A
N/A	Shared Landing?	N/A			
N/A	Gutter Ponding?	N/A	N/A	Gutter Slope (%)	N/A
N/A	Gutter Lip Ht (in)	N/A	N/A	Gutter X Slope (%)	N/A
N/A	Painted X Walk1?	Yes	N/A	Painted X Walk2?	Yes
	X Walk 1 Direction	To S		X Walk 2 Direction	To E
N/A	X Walk 1 Width (in)	113.0	N/A	X Walk 2 Width (in)	110.0
	X Walk 1 Slope (%)	1.7		X Walk 2 Slope (%)	3.6
	X Walk 1 X Slope (%)	6.0		X Walk 2 X Slope (%)	2.0

N/A	Ramp inside XWalk1?	Yes	N/A	Ramp inside XWalk2?	Yes
	Road Slope (%)	5.2	N/A	Clear Space?	N/A
	Road X Slope (%)	2.3	N/A	Clear Space to XWalk (in)	N/A
N/A	Any Obstructions?	N/A	N/A	Storm Grate/Utility Hazard?	N/A
	Obstruction Type			Storm Grate/Utility Type	
		N/A			N/A
		Yes		Surface Condition? (G/P)	Good

**Remove & Replace Curb Ramp With Two New Directional Ramps or Equivalent.**
