Access Compliance Report

Public Rights-of-Way

(Curb Ramps)

Intersection ID: 18202	Main Street: CLOVER_RD	Cross Street: S_SHARON_AMITY_RD	Location: SE
ADA ID: 149E4A8C7C50	Ramp Type: PerpDiag	Initial Pass/Fail: Fail	Overall Compliance: No
Codes/Mitigation Info/Possible Solution		Field Measurements/Component Compliance	
Severity Score: 10

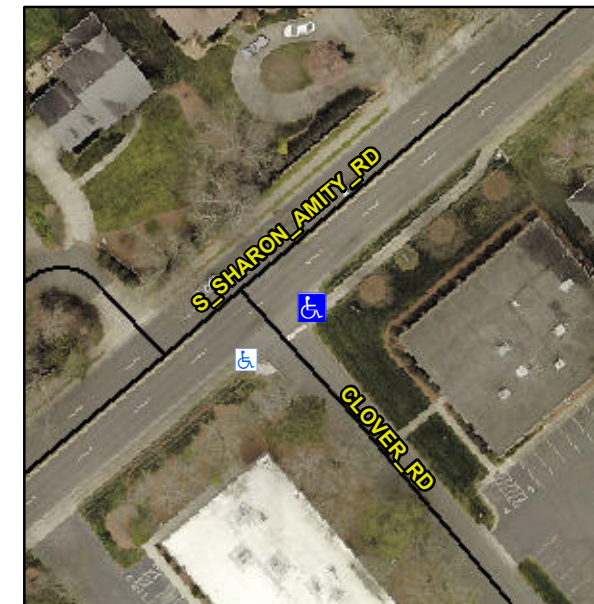
Not Found, R304.5.1, R304.5.3

Compliance	Description	Data	Compliance	Description	Data
N/A	Ramp Length (in)	71.0	Yes	Ramp Slope (%)	6.5
No	Ramp Width (in)	45.0	No	Ramp XSlope (%)	3.3
N/A	Flare Type LT	N/A	N/A	Flare Type RT	N/A
N/A	Flare Slope LT (%)	N/A	N/A	Flare Slope RT (%)	N/A
N/A	Flare Traversable LT?	N/A	N/A	Flare Traversable RT?	N/A
N/A	Landing Length (in)	N/A	N/A	DWS Provided?	N/A
N/A	Landing Width (in)	N/A	N/A	DWS Contrast?	N/A
N/A	Landing Slope (%)	N/A	N/A	DWS Length (in)	N/A
N/A	Landing X Slope (%)	N/A	N/A	DWS Full Width?	N/A
N/A	Landing Curb? (Y/N)	N/A	N/A	DWS Offset (in)	N/A
N/A	Shared Landing?	N/A			
N/A	Gutter Ponding?	N/A	N/A	Gutter Slope (%)	N/A
N/A	Gutter Lip Ht (in)	N/A	N/A	Gutter X Slope (%)	N/A
N/A	Painted X Walk1?	No	N/A	Painted X Walk2?	No
	X Walk 1 Direction	To NW		X Walk 2 Direction	To SW
N/A	X Walk 1 Width (in)	N/A	N/A	X Walk 2 Width (in)	N/A
	X Walk 1 Slope (%)	1.2		X Walk 2 Slope (%)	2.0
	X Walk 1 X Slope (%)	3.6		X Walk 2 X Slope (%)	0.6

N/A	Ramp inside XWalk1?	N/A	N/A	Ramp inside XWalk2?	N/A
	Road Slope (%)	1.4	N/A	Clear Space?	N/A
	Road X Slope (%)	1.3	N/A	Clear Space to XWalk (in)	N/A
N/A	Any Obstructions?	N/A	N/A	Storm Grate/Utility Hazard?	N/A
	Obstruction Type			Storm Grate/Utility Type	
		N/A			N/A
			Yes	Surface Condition? (G/P)	Good

Remove & Replace Curb Ramp With Two New Directional Ramps or Equivalent.
