Access Compliance Report Public Rights-of-Way (Curb Ramps)

Intersection ID: 15599 Main Street: COLVILLE RD **Cross Street: EASTOVER RD** Location: SW Ramp Type: PerpDiag Initial Pass/Fail: Fail **Overall Compliance: No Severity Score:** 1.25 **ADA ID: 14A191A8EB6F**

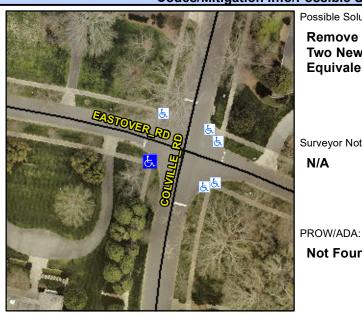
Compliance Description		Data	Comp	iance Description	Data
N/A	Ramp Length (in)	60.0	Yes	Ramp Slope (%)	7.0
Yes	Ramp Width (in)	48.0	No	Ramp XSlope (%)	2.9
N/A	Flare Type LT	N/A	N/A	Flare Type RT	N/A
N/A	Flare Slope LT (%)	N/A	N/A	Flare Slope RT (%)	N/A
N/A	Flare Traversable LT?	N/A	N/A	Flare Traversable F	RT? N/A
N/A	Landing Length (in)	N/A	N/A	DWS Provided?	N/A
N/A	Landing Width (in)	N/A	N/A	DWS Contrast?	N/A
N/A	Landing Slope (%)	N/A	N/A	DWS Length (in)	N/A
N/A	Landing X Slope (%)	N/A	N/A	DWS Full Width?	N/A
N/A	Landing Curb? (Y/N)	N/A	N/A	DWS Offset (in)	N/A
N/A	Shared Landing?	N/A			
N/A	Gutter Ponding?	N/A	N/A	Gutter Slope (%)	N/A
N/A	Gutter Lip Ht (in)	N/A	N/A	Gutter X Slope (%)	N/A
N/A	Painted X Walk1?	No	N/A	Painted X Walk2?	No
	X Walk 1 Direction	To SE		X Walk 2 Direction	To NE
N/A	X Walk 1 Width (in)	N/A	N/A	X Walk 2 Width (in)	N/A
	X Walk 1 Slope (%)	3.0		X Walk 2 Slope (%)	0.3
	X Walk 1 X Slope (%)	0.0		X Walk 2 X Slope (%) 1.6

N/A	Ramp inside XWalk1?	N/A	N/A	Ramp inside XWall	(2? N/A
	Road Slope (%)	0.7	N/A	Clear Space?	N/A
	Road X Slope (%)	3.6	N/A	Clear Space to XW	alk (in) N/A
N/A	Any Obstructions?	N/A	N/A	Storm Grate/Utility	Hazard? N/A
	Obstruction Type		l	Storm Grate/Utility	Туре
		N/A			N/A

Street 1 Name Stop Condition-Street 2 Street 2 Name Stop Condition-Street 1 Possible Solutions: Remove & Replace Curb Ramp With Two New Directional Ramps or Equivalent. Surveyor Notes: N/A
