# Access Compliance Report

## Public Rights-of-Way

| Intersection ID: 13618 | Main Street: S_CALDWELL_ST | Cross Street: TEMPLETON_AV | Location: S |
| ADA ID: 14B4B89D0EAD | Ramp Type: PerpDiag | Initial Pass/Fail: Fail | Overall Compliance: No |

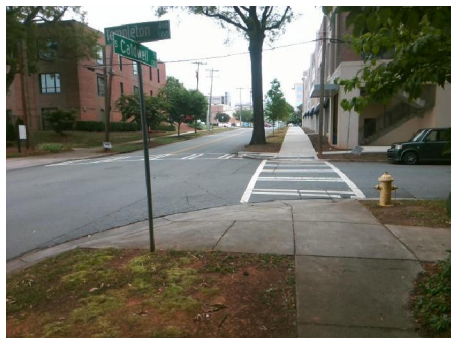
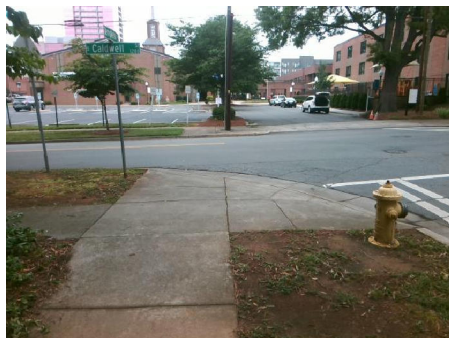
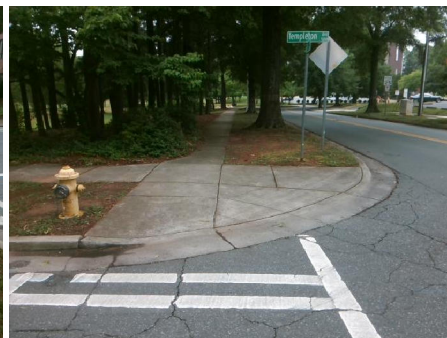
| Compliance | Description | Data | Compliance | Description | Data |
|---|---|---|---|---|---|
| N/A | Ramp Length (in) | 67.0 | No | Ramp Slope (%) | 9.1 |
| Yes | Ramp Width (in) | 192.0 | No | Ramp XSlope (%) | 5.3 |

**Remove & Replace Curb Ramp With Two New Directional Ramps or Equivalent. Restripe Crosswalk.**
