# Access Compliance Report

## Public Rights-of-Way

### (Curb Ramps)

| Intersection ID: 17870 | Main Street: HILLSDALE_AV | Cross Street: TRANQUIL_AV | Location: SE |

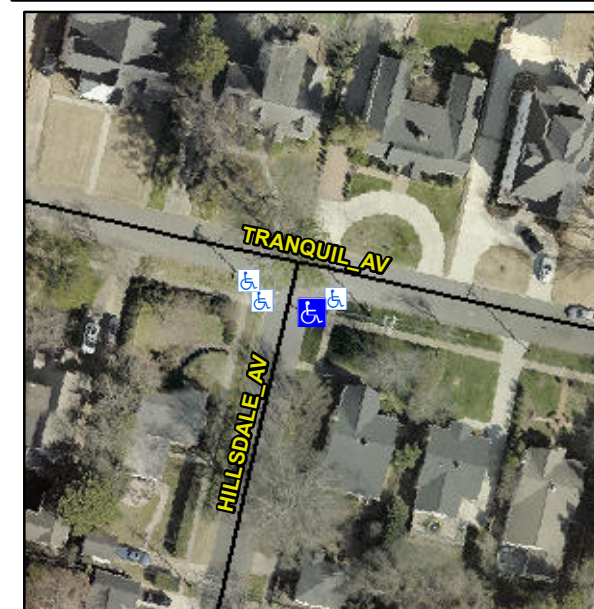
| ADA ID: 14E56ADF93B4 | Ramp Type: Perp | Initial Pass/Fail: Fail | Overall Compliance: No |
| Severity Score: 46.25 | | | |

**Not Found, R304.5.1, R304.2.2, R304.5.3**

| Compliance | Description | Data | Compliance | Description | Data |
|---|---|---|---|---|---|
| N/A | Ramp Length (in) | 111.0 | No | Ramp Slope (%) | 14.1 |
| No | Ramp Width (in) | 42.0 | No | Ramp XSlope (%) | 5.7 |

Possible Solutions:

**Remove & Replace Entire Ramp.**

Total Cost: \$ 1850.00
