Intersection ID: 10132	Main Street: CAMPUS_ST	Cross Street: MILL_RD	Location:	NE
ADA ID: 14E68D200054	Ramp Type: PerpDiag	Initial Pass/Fail: Fail	Overall Compliance: No	Severity Score: 12.5

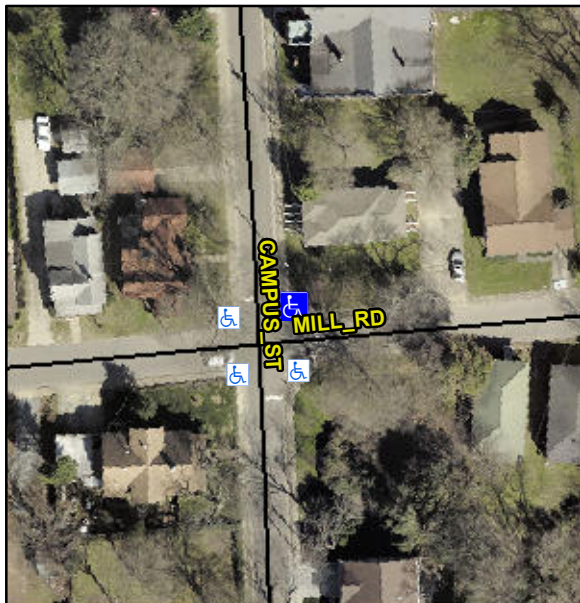
Possible Solutions:		Compliance	Description	Data	Compliance	Description	Data
	Remove & Replace Curb Ramp With Two New Directional Ramps or Equivalent.		N/A	Ramp Length (in)	49.0	Yes	Ramp Slope (%)	6.1
			Yes	Ramp Width (in)	50.0	No	Ramp XSlope (%)	5.2
			N/A	Flare Type LT	N/A	N/A	Flare Type RT	N/A
			N/A	Flare Slope LT (%)	N/A	N/A	Flare Slope RT (%)	N/A
			N/A	Flare Traversable LT?	N/A	N/A	Flare Traversable RT?	N/A
			N/A	Landing Length (in)	N/A	N/A	DWS Provided?	N/A
			N/A	Landing Width (in)	N/A	N/A	DWS Contrast?	N/A
			N/A	Landing Slope (%)	N/A	N/A	DWS Length (in)	N/A
			N/A	Landing X Slope (%)	N/A	N/A	DWS Full Width?	N/A
Surveyor Notes:		N/A	N/A	Landing Curb? (Y/N)	N/A	N/A	DWS Offset (in)	N/A
PROW/ADA:		Not Found, R304.5.3	N/A	Shared Landing?	N/A			
			N/A	Gutter Ponding?	N/A	N/A	Gutter Slope (%)	N/A
			N/A	Gutter Lip Ht (in)	N/A	N/A	Gutter X Slope (%)	N/A

N/A	Painted X Walk1?	No	N/A	Painted X Walk2?	No
				X Walk 1 Direction	To W		X Walk 2 Direction	To S
			N/A	X Walk 1 Width (in)	N/A	N/A	X Walk 2 Width (in)	N/A
				X Walk 1 Slope (%)	2.2		X Walk 2 Slope (%)	3.8
				X Walk 1 X Slope (%)	3.0		X Walk 2 X Slope (%)	4.1
			N/A	Ramp inside XWalk1?	N/A	N/A	Ramp inside XWalk2?	N/A
				Road Slope (%)	5.3	N/A	Clear Space?	N/A
				Road X Slope (%)	1.7	N/A	Clear Space to XWalk (in)	N/A
			N/A	Any Obstructions?	N/A	N/A	Storm Grate/Utility Hazard?	N/A
				Obstruction Type			Storm Grate/Utility Type	
					N/A			N/A
						Yes	Surface Condition? (G/P)	Good
Street 1 Name		CAMPUS ST						
Stop Condition-Street 2		StopSign						
Street 2 Name		MILL RD						
Stop Condition-Street 1		StopSign						
Total Cost:		\$ 3200.00
