## **Access Compliance Report Public Rights-of-Way** (Curb Ramps)

Intersection ID: 10034400 Main Street: PIEDMONT PARK DR Cross Street: SAGE\_PARK\_DR Location: S ADA ID: 14E9780EB551 Ramp Type: Directional1 Initial Pass/Fail: Fail **Overall Compliance: No Severity Score:** 12.5

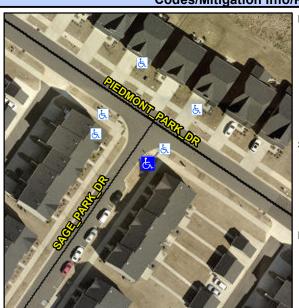
ried Measurements/Component Componence					
Compliance Description		Data	Compliance Description		Data
N/A	Ramp Length (in)	54.0	N/A	Grade Break?	N/A
Yes	Ramp Width (in)	71.0	N/A	Grade Break Slope (%)	0.0
No	Ramp Slope (%)	8.4	N/A	Grade Break XSlope (%)	0.0
Yes	Ramp XSlope (%)	0.9			
N/A	Flare Type LT	N/A	N/A	Flare Type RT	N/A
N/A	Flare Slope LT (%)	N/A	N/A	Flare Slope RT (%)	0.0
N/A	Flare Traversable LT?	N/A	N/A	Flare Traversable RT?	N/A
N/A	Landing Length (in)	0.0	N/A	DWS Provided?	N/A
N/A	Landing Width (in)	0.0	N/A	DWS Contrast?	N/A
N/A	Landing Slope (%)	0.0	N/A	DWS Length (in)	N/A
N/A	Landing X Slope (%)	0.0	N/A	DWS Full Width?	N/A
N/A	Landing Curb? (Y/N)	N/A	N/A	DWS Offset LT (in)	N/A
N/A	Shared Landing?	N/A	N/A	DWS Offset RT (in)	N/A
N/A	Gutter Ponding?	0.0	N/A	Gutter Slope (%)	N/A
N/A	Gutter Lip Ht (in)	0.0	N/A	Gutter X Slope (%)	N/A
N/A	Painted X Walk1?	No		Road Slope (%)	0.9
	X Walk 1 Direction	To NE		Road X Slope (%)	2.6

X Walk 1 Width (in)	N/A		Clear Space?	N/A
	X Walk 1 Slope (%)	0.9	N/A	Clear Space to XWalk (in)	N/A
	X Walk 1 X Slope (%)	2.6	N/A	Storm Grate/Utility Hazard?	N/A
N/A	Ramp inside XWalk1?	N/A		Storm Grate/Utility Type	
N/A	Any Obstructions?	N/A			N/A
	Obstruction Type		Yes	Surface Condition? (G/P)	Good
		N/A	N/A	Curb Slope (%)	2.5

Possible Solutions: Remove & Replace Entire Ramp. Surveyor Notes: N/A PROW/ADA: R304.2.2

Total Cost: 1600.00
