# Access Compliance Report

## Public Rights-of-Way

### (Curb Ramps)

| Intersection ID: 22230 | Main Street: N_SARDIS_VIEW_LN | Cross Street: SARDIS_RD | Location: NE |

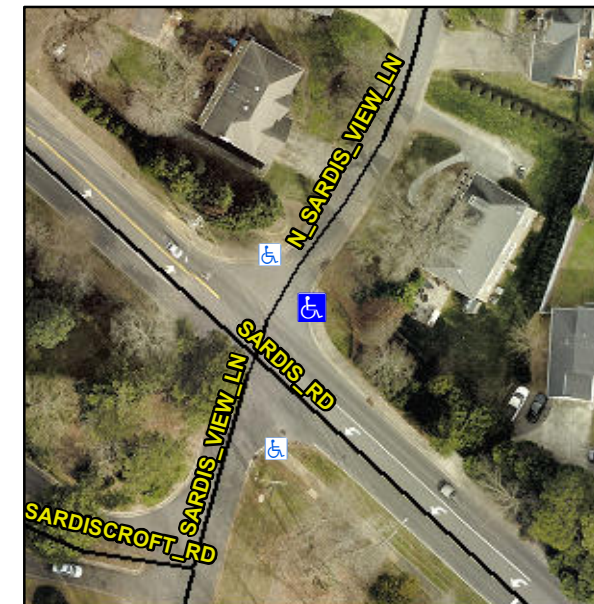
**LT RP < 5%**

**R304.5.3, R304.3.2**

| Compliance | Description | Data | Compliance | Description | Data |
|---|---|---|---|---|---|
| Yes | Ramp Slope LT (%) | 1.1 | No | Ramp Slope RT (%) | 14.0 |
| No | Ramp XSlope LT (%) | 3.6 | No | Ramp XSlope RT (%) | 2.7 |

**Remove & Replace Curb Ramp With Two New Directional Ramps or Equivalent.**
