Access Compliance Report

Public Rights-of-Way

(Curb Ramps)

Intersection ID: 51397	Main Street: WINDYRUSH_RD	Cross Street: BANFIELD_PL	Location: S
ADA ID: 14F0D757DB84	Ramp Type: PerpDiag	Initial Pass/Fail: Fail	Overall Compliance: No
Severity Score: 10			
Codes/Mitigation Info/Possible Solution		Field Measurements/Component Compliance

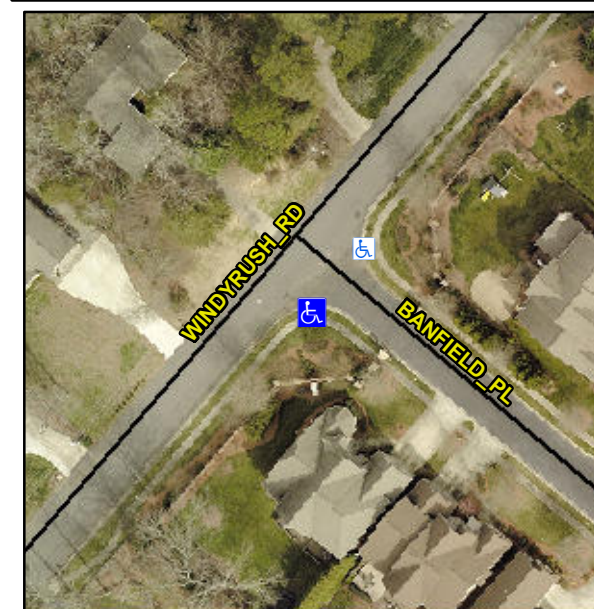
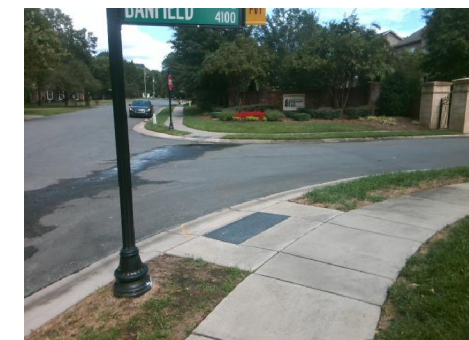
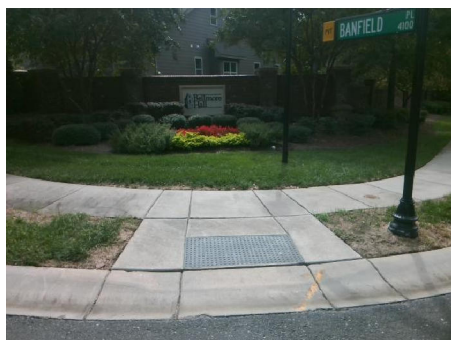
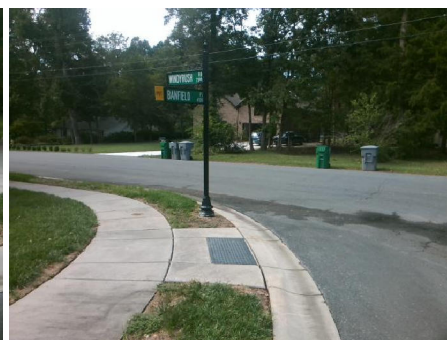
Not Found, R304.5.1, R304.5.3

Compliance	Description	Data	Compliance	Description	Data
N/A	Ramp Length (in)	46.0	Yes	Ramp Slope (%)	5.6
No	Ramp Width (in)	44.0	No	Ramp XSlope (%)	3.9
N/A	Flare Type LT	N/A	N/A	Flare Type RT	N/A
N/A	Flare Slope LT (%)	N/A	N/A	Flare Slope RT (%)	N/A
N/A	Flare Traversable LT?	N/A	N/A	Flare Traversable RT?	N/A
N/A	Landing Length (in)	N/A	N/A	DWS Provided?	N/A
N/A	Landing Width (in)	N/A	N/A	DWS Contrast?	N/A
N/A	Landing Slope (%)	N/A	N/A	DWS Length (in)	N/A
N/A	Landing X Slope (%)	N/A	N/A	DWS Full Width?	N/A
N/A	Landing Curb? (Y/N)	N/A	N/A	DWS Offset (in)	N/A
N/A	Shared Landing?	N/A			
N/A	Gutter Ponding?	N/A	N/A	Gutter Slope (%)	N/A
N/A	Gutter Lip Ht (in)	N/A	N/A	Gutter X Slope (%)	N/A
N/A	Painted X Walk1?	No	N/A	Painted X Walk2?	No
	X Walk 1 Direction	To NE		X Walk 2 Direction	To NW
N/A	X Walk 1 Width (in)	N/A	N/A	X Walk 2 Width (in)	N/A
	X Walk 1 Slope (%)	1.4		X Walk 2 Slope (%)	3.0
	X Walk 1 X Slope (%)	2.7		X Walk 2 X Slope (%)	1.8

N/A	Ramp inside XWalk1?	N/A	N/A	Ramp inside XWalk2?	N/A
	Road Slope (%)	2.1	N/A	Clear Space?	N/A
	Road X Slope (%)	1.2	N/A	Clear Space to XWalk (in)	N/A
N/A	Any Obstructions?	N/A	N/A	Storm Grate/Utility Hazard?	N/A
	Obstruction Type			Storm Grate/Utility Type	
		N/A			N/A
		Yes		Surface Condition? (G/P)	Good

Remove & Replace Curb Ramp With Two New Directional Ramps or Equivalent.

Total Cost: \$ 3200.00
