Access Compliance Report

Public Rights-of-Way

(Curb Ramps)

Intersection ID: 26286	Main Street: BEVINGTON_BROOK_LN	Cross Street: BEVINGTON_WOODS_LN	Location: E
ADA ID: 14F309195B8D	Ramp Type: PerpDiag	Initial Pass/Fail: Fail	Overall Compliance: No
Severity Score: 21.25			
Codes/Mitigation Info/Possible Solution		Field Measurements/Component Compliance

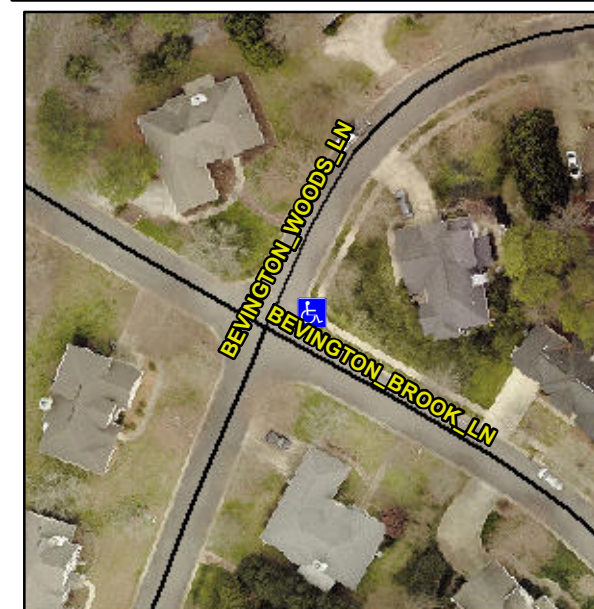
Not Found, R304.5.1, R304.5.3

Compliance	Description	Data	Compliance	Description	Data
N/A	Ramp Length (in)	92.0	Yes	Ramp Slope (%)	6.9
No	Ramp Width (in)	47.0	No	Ramp XSlope (%)	5.2
N/A	Flare Type LT	N/A	N/A	Flare Type RT	N/A
N/A	Flare Slope LT (%)	N/A	N/A	Flare Slope RT (%)	N/A
N/A	Flare Traversable LT?	N/A	N/A	Flare Traversable RT?	N/A
N/A	Landing Length (in)	N/A	N/A	DWS Provided?	N/A
N/A	Landing Width (in)	N/A	N/A	DWS Contrast?	N/A
N/A	Landing Slope (%)	N/A	N/A	DWS Length (in)	N/A
N/A	Landing X Slope (%)	N/A	N/A	DWS Full Width?	N/A
N/A	Landing Curb? (Y/N)	N/A	N/A	DWS Offset (in)	N/A
N/A	Shared Landing?	N/A			
N/A	Gutter Ponding?	N/A	N/A	Gutter Slope (%)	N/A
N/A	Gutter Lip Ht (in)	N/A	N/A	Gutter X Slope (%)	N/A
N/A	Painted X Walk1?	No	N/A	Painted X Walk2?	No
	X Walk 1 Direction	To NW		X Walk 2 Direction	To SW
N/A	X Walk 1 Width (in)	N/A	N/A	X Walk 2 Width (in)	N/A
	X Walk 1 Slope (%)	2.6		X Walk 2 Slope (%)	3.3
	X Walk 1 X Slope (%)	1.4		X Walk 2 X Slope (%)	1.0

N/A	Ramp inside XWalk1?	N/A	N/A	Ramp inside XWalk2?	N/A
	Road Slope (%)	3.0	N/A	Clear Space?	N/A
	Road X Slope (%)	0.2	N/A	Clear Space to XWalk (in)	N/A
N/A	Any Obstructions?	N/A	N/A	Storm Grate/Utility Hazard?	N/A
	Obstruction Type			Storm Grate/Utility Type	
		N/A			N/A
			Yes	Surface Condition? (G/P)	Good

Possible Solutions:

Remove & Replace Curb Ramp With Two New Directional Ramps or Equivalent.
