Access Compliance Report

Public Rights-of-Way

(Curb Ramps)

Intersection ID: 14400		Main Street: BERKELEY_AV		Cross Street: DILWORTH_RD		Location: SW													
ADA ID: 14FAD27D170D		Ramp Type: Directional1		Initial Pass/Fail: Fail		Overall Compliance: No		Severity Score: 25											
Codes/Mitigation Info/Possible Solution				Field Measurements/Component Compliance

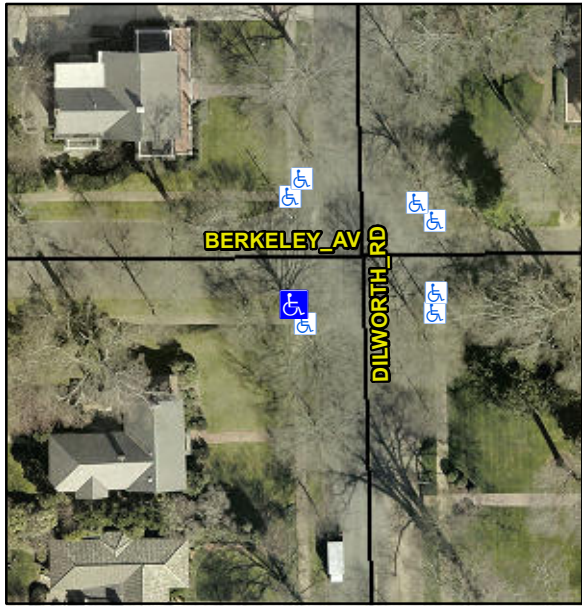
<div>Street 1 NameBERKELEY AV</div> <div>Stop Condition-Street 1StopSign</div> <div>Street 2 NameN/A</div> <div>Stop Condition-Street 2N/A</div>				Possible Solutions:		Compliance		Description		Data		Compliance		Description		Data			
				Remove & Replace Entire Ramp.		N/A		Ramp Length (in)		26.0		N/A		Grade Break?		N/A		N/A	
						Yes		Ramp Width (in)		72.0		N/A		Grade Break Slope (%)		0.0		0.0	
						Yes		Ramp Slope (%)		7.0		N/A		Grade Break XSlope (%)					
						No		Ramp XSlope (%)		7.0									
						N/A		Flare Type LT		N/A		N/A		Flare Type RT		N/A		N/A	
						N/A		Flare Slope LT (%)		N/A		N/A		Flare Slope RT (%)		0.0		0.0

N/A		Flare Traversable LT?		N/A		N/A		Flare Traversable RT?		N/A		N/A	
						N/A		Landing Length (in)		0.0		N/A		DWS Provided?		N/A		N/A	
						N/A		Landing Width (in)		0.0		N/A		DWS Contrast?		N/A		N/A	
		N/A		Landing Slope (%)		0.0		N/A		DWS Length (in)		N/A		N/A					
		N/A		Landing X Slope (%)		0.0		N/A		DWS Full Width?		N/A		N/A					
		N/A		Landing Curb? (Y/N)		N/A		N/A		DWS Offset LT (in)		N/A		N/A					
		N/A		Shared Landing?		N/A		N/A		DWS Offset RT (in)		N/A		N/A					
		N/A		Gutter Ponding?		0.0		N/A		Gutter Slope (%)		N/A		N/A					
		N/A		Gutter Lip Ht (in)		1.0		N/A		Gutter X Slope (%)		N/A		N/A					
		N/A		Painted X Walk1?		No				Road Slope (%)		8.5		8.5					
				X Walk 1 Direction		To NW				Road X Slope (%)		2.3		2.3					
				X Walk 1 Width (in)		N/A				Clear Space?		N/A		N/A					
				X Walk 1 Slope (%)		8.5		N/A		Clear Space to XWalk (in)		N/A		N/A					
				X Walk 1 X Slope (%)		2.3		N/A		Storm Grate/Utility Hazard?		N/A		N/A

N/A		Ramp inside XWalk1?		N/A		Storm Grate/Utility Type									
				N/A		Any Obstructions?		N/A				N/A		N/A					
						Obstruction Type				Yes		Surface Condition? (G/P)		Good					
								N/A		N/A		Curb Slope (%)		25.7					
				Surveyor Notes:															
				N/A															
				PROW/ADA:															
				R304.5.3
