## **Access Compliance Report Public Rights-of-Way** (Curb Ramps)

Intersection ID: 43118 Main Street: GRACE ST Cross Street: THE\_PLAZA Location: SW ADA ID: 15152891BA8C Ramp Type: Para Initial Pass/Fail: Fail **Overall Compliance: No Severity Score:** 25

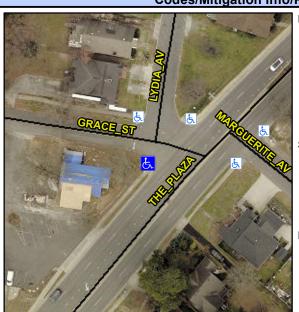
Field Measurements/Component Compliance					
Compliance Description		Data	Comp	liance Description	Data
N/A	Ramp Length LT (in)	44.5	N/A	Ramp Length RT (in)	48.0
Yes	Ramp Width LT (in)	55.0	Yes	Ramp Width RT (in)	54.0
No	Ramp Slope LT (%)	10.4	Yes	Ramp Slope RT (%)	6.3
No	Ramp XSlope LT (%)	6.6	Yes	Ramp XSlope RT (%)	0.8
N/A	Landing Length (in)	N/A	N/A	DWS Provided?	N/A
N/A	Landing Width (in)	N/A	N/A	DWS Contrast?	N/A
N/A	Landing Slope (%)	N/A	N/A	DWS Length (in)	N/A
N/A	Landing X Slope (%)	N/A	N/A	DWS Full Width?	N/A
N/A	Landing Curb? (Y/N)	N/A	N/A	DWS Offset (in)	N/A
N/A	Shared Landing?	N/A			
N/A	Gutter Ponding?	N/A	N/A	Gutter Slope (%)	N/A
N/A	Gutter Lip Ht (in)	1.0	N/A	Gutter X Slope (%)	N/A
N/A	Painted X Walk1?	No	N/A	Painted X Walk2?	N/A
	X Walk 1 Direction	To NE		X Walk 2 Direction	N/A
N/A	X Walk 1 Width (in)	N/A	N/A	X Walk 2 Width (in)	N/A
	X Walk 1 Slope (%)	1.1		X Walk 2 Slope (%)	N/A
	X Walk 1 X Slope (%)	5.5		X Walk 2 X Slope (%)	N/A

**GRACE ST** Street 1 Name Stop Condition-Street 1 StopSign Street 2 Name N/A Stop Condition-Street 2 N/A Possible Solutions: Remove & Replace Entire Ramp. Surveyor Notes: N/A PROW/ADA: R304.3.2, R304.5.3
