Access Compliance Report

Public Rights-of-Way

(Curb Ramps)

Intersection ID: 10569	Main Street: PLYMOUTH_AV	Cross Street: BANCROFT_ST	Location:	E
ADA ID: 151979BF528D	Ramp Type: Perp	Initial Pass/Fail: Fail	Overall Compliance: No	Severity Score: 10
Codes/Mitigation Info/Possible Solution		Field Measurements/Component Compliance

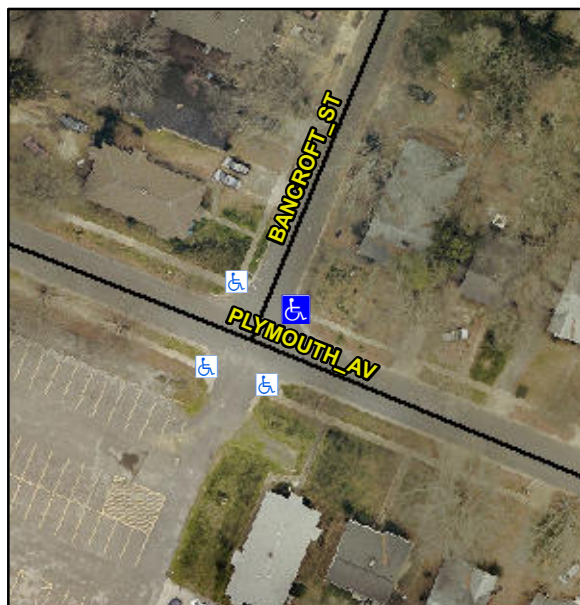
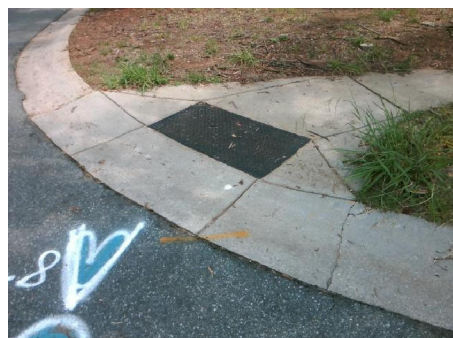
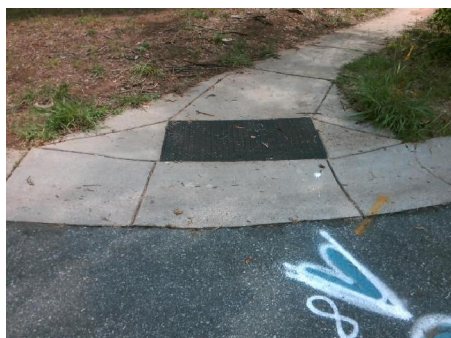
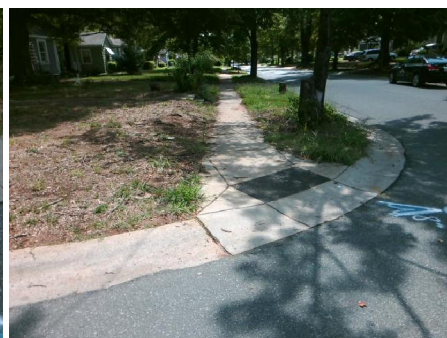
Not Found, R304.5.1, R304.5.3

Compliance	Description	Data	Compliance	Description	Data
N/A	Ramp Length (in)	25.0	Yes	Ramp Slope (%)	7.1
No	Ramp Width (in)	44.0	No	Ramp XSlope (%)	4.3
N/A	Flare Type LT	N/A	N/A	Flare Type RT	N/A
N/A	Flare Slope LT (%)	N/A	N/A	Flare Slope RT (%)	N/A
N/A	Flare Traversable LT?	N/A	N/A	Flare Traversable RT?	N/A
N/A	Landing Length (in)	N/A	N/A	DWS Provided?	N/A
N/A	Landing Width (in)	N/A	N/A	DWS Contrast?	N/A
N/A	Landing Slope (%)	N/A	N/A	DWS Length (in)	N/A
N/A	Landing X Slope (%)	N/A	N/A	DWS Full Width?	N/A
N/A	Landing Curb? (Y/N)	N/A	N/A	DWS Offset (in)	N/A
N/A	Shared Landing?	N/A			
N/A	Gutter Ponding?	N/A	N/A	Gutter Slope (%)	N/A
N/A	Gutter Lip Ht (in)	1.5	N/A	Gutter X Slope (%)	N/A
N/A	Painted X Walk1?	No	N/A	Painted X Walk2?	N/A
	X Walk 1 Direction	To NW		X Walk 2 Direction	N/A
N/A	X Walk 1 Width (in)	N/A	N/A	X Walk 2 Width (in)	N/A
	X Walk 1 Slope (%)	3.4		X Walk 2 Slope (%)	N/A
	X Walk 1 X Slope (%)	3.9		X Walk 2 X Slope (%)	N/A

N/A	Ramp inside XWalk1?	N/A	N/A	Ramp inside XWalk2?	N/A
	Road Slope (%)	N/A	N/A	Clear Space?	N/A
	Road X Slope (%)	N/A	N/A	Clear Space to XWalk (in)	N/A
N/A	Any Obstructions?	N/A	N/A	Storm Grate/Utility Hazard?	N/A
	Obstruction Type			Storm Grate/Utility Type	
		N/A			N/A
			Yes	Surface Condition? (G/P)	Good

Remove & Replace Entire Ramp.
