## Access Compliance Report Public Rights-of-Way (Curb Ramps)

· · · ·									
Intersection ID: 16355	Main Street: HILLBOURN_DR			Cross Street: IDLEBROOK_DR				Location:	SW
ADA ID: 151EA22F0B1B	Ramp Type: PerpDiag			nitial Pass/Fail: Fail Overall Compliance: No				o Severity Score:	21.25
Codes/Mitigation Info/Possible Solution				Field Measurements/Component Compliance					
Possible Solutions:				Compliance Description Data Compliance Description					Data

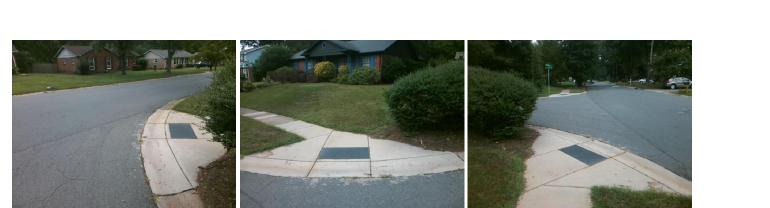
2. RC	12								
		Remove & Replace Curb Ramp		N/A	Ramp Length (in)	67.0		Ramp Slope (%)	5.6
		Two New Directional Ramps or Equivalent.		No	Ramp Width (in)	46.0		Ramp XSlope (%)	5.3
		Equivalent.		N/A	Flare Type LT	N/A		Flare Type RT	N/A
alland - allast Ett	I SAL			N/A	Flare Slope LT (%)	N/A	N/A	Flare Slope RT (%)	N/A
LILLBOURN DE	al second			N/A	Flare Traversable LT?	N/A	N/A	Flare Traversable RT?	N/A
				N/A	Landing Length (in)	N/A	N/A	DWS Provided?	N/A
A State of the sta		Surveyor Notes:		N/A	Landing Width (in)	N/A	N/A	DWS Contrast?	N/A
<b>6</b>	A Da	N/A		N/A	Landing Slope (%)	N/A	N/A	DWS Length (in)	N/A
				N/A	Landing X Slope (%)	N/A	N/A	DWS Full Width?	N/A
	Contraction of the			N/A	Landing Curb? (Y/N)	N/A	N/A	DWS Offset (in)	N/A
A I Meras	1 and the stand			N/A	Shared Landing?	N/A			
		PROW/ADA:		N/A	Gutter Ponding?	N/A	N/A	Gutter Slope (%)	N/A
		Not Found, R304.5.1, R304.5.3		N/A	Gutter Lip Ht (in)	N/A	N/A	Gutter X Slope (%)	N/A

at all a set	and a start			N/A	Painted X Walk1?	No	N/A	Painted X Walk2?	No
A DIT From					X Walk 1 Direction	To SE		X Walk 2 Direction	To NE
				N/A	X Walk 1 Width (in)	N/A	N/A	X Walk 2 Width (in)	N/A
Street 1 Name	IDLEBROOK DR				X Walk 1 Slope (%)	2.2		X Walk 2 Slope (%)	2.8
Stop Condition-Street 2	None				X Walk 1 X Slope (%)	3.2		X Walk 2 X Slope (%)	4.1
Street 2 Name	HILLBOURN DR			N/A	Ramp inside XWalk1?	N/A	N/A	Ramp inside XWalk2?	N/A
Stop Condition-Street 1	StopSign				Road Slope (%)	5.0	N/A	Clear Space?	N/A
