Access Compliance Report

Public Rights-of-Way

(Curb Ramps)

Intersection ID: 50638	Main Street: RUBY_VALLEY_RD	Cross Street: BLUE_GROVE_RD	Location: NE
ADA ID: 1525CFA24ABC	Ramp Type: Perp	Initial Pass/Fail: Fail	Overall Compliance: No
Severity Score: 1.25			
Codes/Mitigation Info/Possible Solution		Field Measurements/Component Compliance

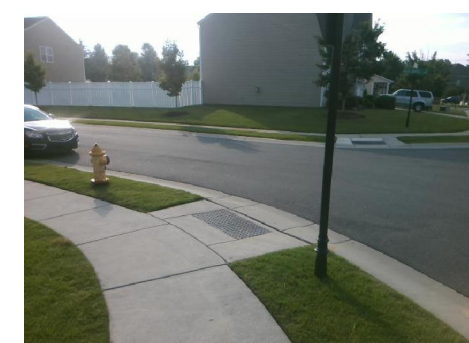
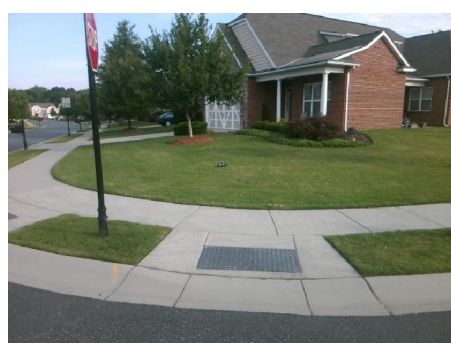
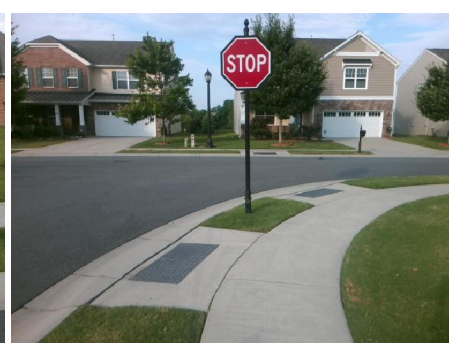
Not Found, R304.5.3

Compliance	Description	Data	Compliance	Description	Data
N/A	Ramp Length (in)	48.0	Yes	Ramp Slope (%)	6.6
Yes	Ramp Width (in)	48.0	No	Ramp XSlope (%)	2.2
N/A	Flare Type LT	N/A	N/A	Flare Type RT	N/A
N/A	Flare Slope LT (%)	N/A	N/A	Flare Slope RT (%)	N/A
N/A	Flare Traversable LT?	N/A	N/A	Flare Traversable RT?	N/A
N/A	Landing Length (in)	N/A	N/A	DWS Provided?	N/A
N/A	Landing Width (in)	N/A	N/A	DWS Contrast?	N/A
N/A	Landing Slope (%)	N/A	N/A	DWS Length (in)	N/A
N/A	Landing X Slope (%)	N/A	N/A	DWS Full Width?	N/A
N/A	Landing Curb? (Y/N)	N/A	N/A	DWS Offset (in)	N/A
N/A	Shared Landing?	N/A			
N/A	Gutter Ponding?	N/A	N/A	Gutter Slope (%)	N/A
N/A	Gutter Lip Ht (in)	N/A	N/A	Gutter X Slope (%)	N/A
N/A	Painted X Walk1?	No	N/A	Painted X Walk2?	N/A
	X Walk 1 Direction	To SE		X Walk 2 Direction	N/A
N/A	X Walk 1 Width (in)	N/A	N/A	X Walk 2 Width (in)	N/A
	X Walk 1 Slope (%)	1.2		X Walk 2 Slope (%)	N/A
	X Walk 1 X Slope (%)	2.1		X Walk 2 X Slope (%)	N/A

N/A	Ramp inside XWalk1?	N/A	N/A	Ramp inside XWalk2?	N/A
	Road Slope (%)	N/A	N/A	Clear Space?	N/A
	Road X Slope (%)	N/A	N/A	Clear Space to XWalk (in)	N/A
N/A	Any Obstructions?	N/A	N/A	Storm Grate/Utility Hazard?	N/A
	Obstruction Type			Storm Grate/Utility Type	
		N/A			N/A
			Yes	Surface Condition? (G/P)	Good

Remove & Replace Entire Ramp.
