Access Compliance Report

Public Rights-of-Way (Curb Ramps)

Intersection ID: 15139	Main Street: EAST_BV	Cross Street: KENILWORTH_AV	Location: E
ADA ID: 15287E169634	Ramp Type: BlendTrans1	Initial Pass/Fail: Fail	Overall Compliance: No
Severity Score: 12.5			
Codes/Mitigation Info/Possible Solution		Field Measurements/Component Compliance

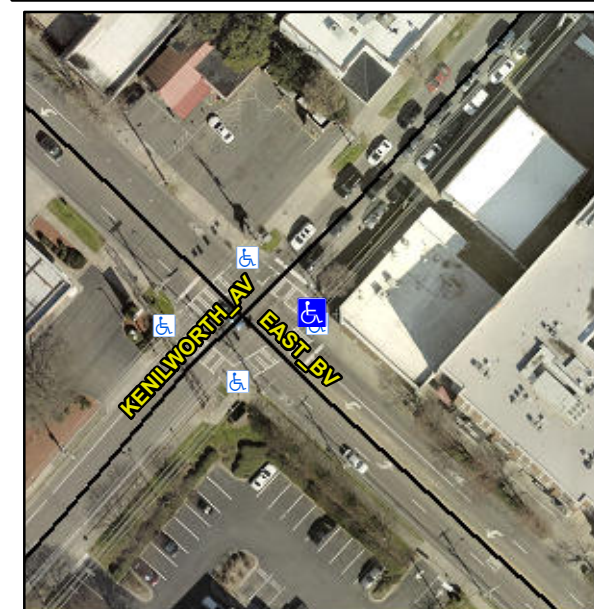
Compliance	Description	Data	Compliance	Description	Data
N/A	Ramp Length (in)	61.0	Yes	BlendTrans Slope (%)	3.9
Yes	Ramp Width (in)	48.0	No	BlendTrans XSlope (%)	6.6
N/A	Flare Type LT	N/A	N/A	Flare Type RT	N/A
N/A	Flare Slope LT (%)	N/A	N/A	Flare Slope RT (%)	N/A
N/A	Flare Traversable LT?	N/A	N/A	Flare Traversable RT?	N/A
N/A	Landing Length (in)	N/A	N/A	DWS Provided?	N/A
N/A	Landing Width (in)	N/A	N/A	DWS Contrast?	N/A
N/A	Landing Slope (%)	N/A	N/A	DWS Length (in)	N/A
N/A	Landing X Slope (%)	N/A	N/A	DWS Full Width?	N/A
N/A	Landing Curb? (Y/N)	N/A	N/A	DWS Offset (in)	N/A
N/A	Shared Landing?	N/A			
N/A	Gutter Ponding?	N/A	N/A	Gutter Slope (%)	N/A
N/A	Gutter Lip Ht (in)	N/A	N/A	Gutter X Slope (%)	N/A
N/A	Painted X Walk1?	Yes	N/A	Painted X Walk2?	N/A
	X Walk 1 Direction	To NW		X Walk 2 Direction	N/A
	X Walk 1 Width (in)	110.0		X Walk 2 Width (in)	N/A
	X Walk 1 Slope (%)	5.3		X Walk 2 Slope (%)	N/A
	X Walk 1 X Slope (%)	1.2		X Walk 2 X Slope (%)	N/A

N/A	Ramp inside XWalk1?	Yes	N/A	Ramp inside XWalk2?	N/A
	Road Slope (%)	1.2		Clear Space?	N/A
	Road X Slope (%)	5.3	N/A	Clear Space to XWalk (in)	N/A
N/A	Any Obstructions?	N/A	N/A	Storm Grate/Utility Hazard?	N/A
	Obstruction Type			Storm Grate/Utility Type	
		N/A			N/A
			Yes	Surface Condition? (G/P)	Good
			N/A	Curb Slope (%)	0.3

Possible Solutions:

Remove & Replace Curb Ramp With Two New Directional Ramps or Equivalent.

R304.5.3
