# Access Compliance Report

## Public Rights-of-Way

### (Curb Ramps)

Intersection ID: 17966	Main Street: GAYNOR_RD	Cross Street: HARDWICK_RD	Location: NW
ADA ID: 153CA83F107F	Ramp Type: PerpDiag	Initial Pass/Fail: Fail	Overall Compliance: No
Codes/Mitigation Info/Possible Solution		Field Measurements/Component Compliance

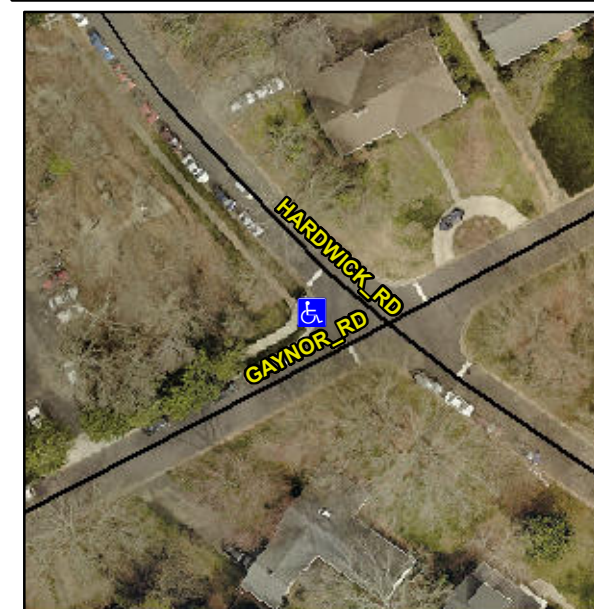
**Not Found, R304.5.3**

Compliance	Description	Data	Compliance	Description	Data
N/A	Ramp Length (in)	65.0	Yes	Ramp Slope (%)	7.4
Yes	Ramp Width (in)	137.0	No	Ramp XSlope (%)	4.0
N/A	Flare Type LT	N/A	N/A	Flare Type RT	N/A
N/A	Flare Slope LT (%)	N/A	N/A	Flare Slope RT (%)	N/A
N/A	Flare Traversable LT?	N/A	N/A	Flare Traversable RT?	N/A
N/A	Landing Length (in)	N/A	N/A	DWS Provided?	N/A
N/A	Landing Width (in)	N/A	N/A	DWS Contrast?	N/A
N/A	Landing Slope (%)	N/A	N/A	DWS Length (in)	N/A
N/A	Landing X Slope (%)	N/A	N/A	DWS Full Width?	N/A
N/A	Landing Curb? (Y/N)	N/A	N/A	DWS Offset (in)	N/A
N/A	Shared Landing?	N/A			
N/A	Gutter Ponding?	N/A	N/A	Gutter Slope (%)	N/A
N/A	Gutter Lip Ht (in)	N/A	N/A	Gutter X Slope (%)	N/A
N/A	Painted X Walk1?	No	N/A	Painted X Walk2?	No
	X Walk 1 Direction	To SE		X Walk 2 Direction	To NE
N/A	X Walk 1 Width (in)	N/A	N/A	X Walk 2 Width (in)	N/A
	X Walk 1 Slope (%)	0.8		X Walk 2 Slope (%)	2.5
	X Walk 1 X Slope (%)	1.7		X Walk 2 X Slope (%)	1.5

N/A	Ramp inside XWalk1?	N/A	N/A	Ramp inside XWalk2?	N/A
	Road Slope (%)	1.7	N/A	Clear Space?	N/A
	Road X Slope (%)	1.4	N/A	Clear Space to XWalk (in)	N/A
N/A	Any Obstructions?	N/A	N/A	Storm Grate/Utility Hazard?	N/A
	Obstruction Type			Storm Grate/Utility Type	
		N/A			N/A
			Yes	Surface Condition? (G/P)	Good

**Remove & Replace Curb Ramp With Two New Directional Ramps or Equivalent.**

Total Cost: \$ 3200.00
