Intersection ID: 9228	Main Street: FAIRMONT_ST	Cross Street: RENNER_ST	Location:	NW
ADA ID: 15520CCD4F8B	Ramp Type: Perp	Initial Pass/Fail: Fail	Overall Compliance: No	Severity Score: 12.5

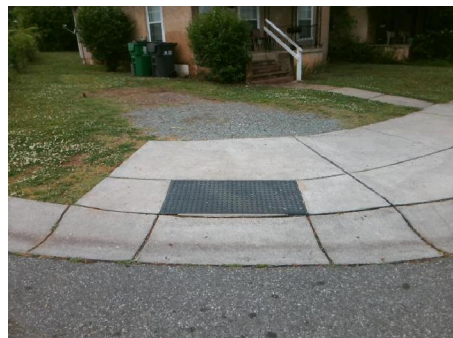
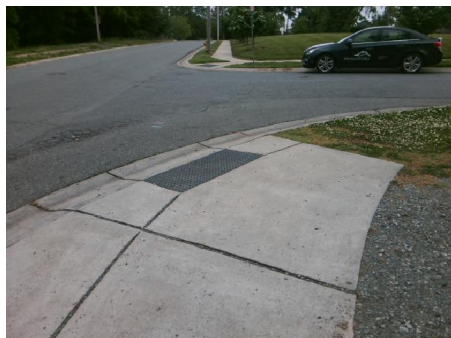
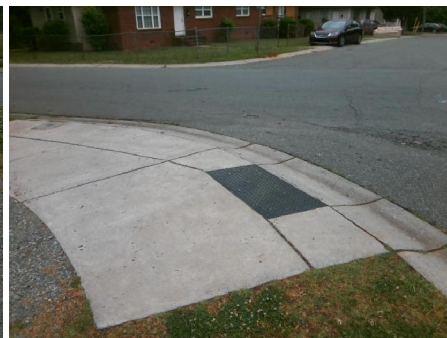
Not Found, R304.5.3

Compliance	Description	Data	Compliance	Description	Data
N/A	Ramp Length (in)	26.5	Yes	Ramp Slope (%)	7.5
Yes	Ramp Width (in)	48.0	No	Ramp XSlope (%)	5.8
N/A	Flare Type LT	N/A	N/A	Flare Type RT	N/A
N/A	Flare Slope LT (%)	N/A	N/A	Flare Slope RT (%)	N/A
N/A	Flare Traversable LT?	N/A	N/A	Flare Traversable RT?	N/A
N/A	Landing Length (in)	N/A	N/A	DWS Provided?	N/A
N/A	Landing Width (in)	N/A	N/A	DWS Contrast?	N/A
N/A	Landing Slope (%)	N/A	N/A	DWS Length (in)	N/A
N/A	Landing X Slope (%)	N/A	N/A	DWS Full Width?	N/A
N/A	Landing Curb? (Y/N)	N/A	N/A	DWS Offset (in)	N/A
N/A	Shared Landing?	N/A			
N/A	Gutter Ponding?	N/A	N/A	Gutter Slope (%)	N/A
N/A	Gutter Lip Ht (in)	N/A	N/A	Gutter X Slope (%)	N/A
N/A	Painted X Walk1?	No	N/A	Painted X Walk2?	N/A
	X Walk 1 Direction	To S		X Walk 2 Direction	N/A
N/A	X Walk 1 Width (in)	N/A	N/A	X Walk 2 Width (in)	N/A
	X Walk 1 Slope (%)	2.4		X Walk 2 Slope (%)	N/A
	X Walk 1 X Slope (%)	4.7		X Walk 2 X Slope (%)	N/A

N/A	Ramp inside XWalk1?	N/A	N/A	Ramp inside XWalk2?	N/A
	Road Slope (%)	N/A	N/A	Clear Space?	N/A
	Road X Slope (%)	N/A	N/A	Clear Space to XWalk (in)	N/A
N/A	Any Obstructions?	N/A	N/A	Storm Grate/Utility Hazard?	N/A
	Obstruction Type			Storm Grate/Utility Type	
		N/A			N/A
			Yes	Surface Condition? (G/P)	Good

Remove & Replace Entire Ramp.
