Access Compliance Report

Public Rights-of-Way

(Curb Ramps)

| Intersection ID: 13487 | Main Street: S_MINT_ST | Cross Street: W_KINGSTON_AV | Location: S |

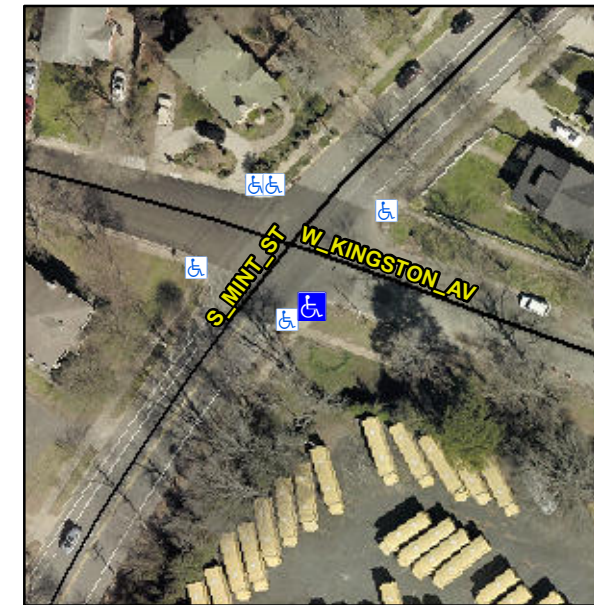
| ADA ID: 157F2FBD7D73 | Ramp Type: Perp | Initial Pass/Fail: Fail | Overall Compliance: No |
| | | | Severity Score: 13.75 |

Not Found, R304.2.2, R304.5.3

| Compliance | Description | Data | Compliance | Description | Data |
|---|---|---|---|---|---|
| N/A | Ramp Length (in) | 55.0 | No | Ramp Slope (%) | 8.5 |
| Yes | Ramp Width (in) | 48.0 | No | Ramp XSlope (%) | 2.3 |

Remove & Replace Entire Ramp.

Total Cost: \$ 1850.00
