Intersection ID: 4801	Main Street: ARKLOW_RD	Cross Street: KARYLSTURN_CT	Location:	E
ADA ID: 158C9D38BF6D	Ramp Type: Perp	Initial Pass/Fail: Fail	Overall Compliance: No	Severity Score: 46.25

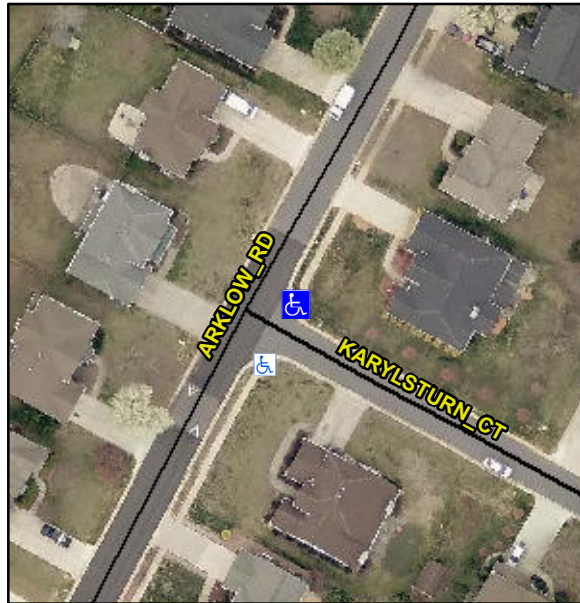
**Not Found, R304.5.1, R304.2.2,
R304.5.3**

Compliance	Description	Data	Compliance	Description	Data
N/A	Ramp Length (in)	46.0	No	Ramp Slope (%)	10.5
No	Ramp Width (in)	46.0	No	Ramp XSlope (%)	8.7
N/A	Flare Type LT	N/A	N/A	Flare Type RT	N/A
N/A	Flare Slope LT (%)	N/A	N/A	Flare Slope RT (%)	N/A
N/A	Flare Traversable LT?	N/A	N/A	Flare Traversable RT?	N/A
N/A	Landing Length (in)	N/A	N/A	DWS Provided?	N/A
N/A	Landing Width (in)	N/A	N/A	DWS Contrast?	N/A
N/A	Landing Slope (%)	N/A	N/A	DWS Length (in)	N/A
N/A	Landing X Slope (%)	N/A	N/A	DWS Full Width?	N/A
N/A	Landing Curb? (Y/N)	N/A	N/A	DWS Offset (in)	N/A
N/A	Shared Landing?	N/A			
N/A	Gutter Ponding?	N/A	N/A	Gutter Slope (%)	N/A
N/A	Gutter Lip Ht (in)	N/A	N/A	Gutter X Slope (%)	N/A
N/A	Painted X Walk1?	No	N/A	Painted X Walk2?	N/A
	X Walk 1 Direction	To SW		X Walk 2 Direction	N/A
N/A	X Walk 1 Width (in)	N/A	N/A	X Walk 2 Width (in)	N/A
	X Walk 1 Slope (%)	2.1		X Walk 2 Slope (%)	N/A
	X Walk 1 X Slope (%)	9.5		X Walk 2 X Slope (%)	N/A

N/A	Ramp inside XWalk1?	N/A	N/A	Ramp inside XWalk2?	N/A
	Road Slope (%)	N/A	N/A	Clear Space?	N/A
	Road X Slope (%)	N/A	N/A	Clear Space to XWalk (in)	N/A
N/A	Any Obstructions?	N/A	N/A	Storm Grate/Utility Hazard?	N/A
	Obstruction Type			Storm Grate/Utility Type	
		N/A			N/A
			Yes	Surface Condition? (G/P)	Good

Possible Solutions:

Remove & Replace Entire Ramp.
