Access Compliance Report Public Rights-of-Way (Curb Ramps)

Intersection ID: 42705 Main Street: PARK_RD Cross Street: SHARON_RD Location: E

ADA ID: 15A5A6F246D8 Ramp Type: IslandPerp Initial Pass/Fail: Fail Overall Compliance: No Severity Score: 13.75

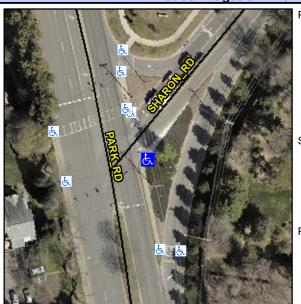
1 Coolbic Coldition	
Possible Solutions:	<u>c</u>
Remove & Replace Entire Ramp.	
	Υ
	N
	N
	N
	N
Surveyor Notes:	N
N/A	N
	N
	N
	N
PROW/ADA:	N
Not Found, R304.2.2, R304.5.3	N
,	N
	N

Field Measurements/Component Compliance							
Comp	liance Description	Data	Comp	liance Description	Data		
N/A	Ramp Length (in)	81.0	No	Ramp Slope (%)	9.2		
Yes	Ramp Width (in)	48.0	No	Ramp XSlope (%)	3.9		
N/A	Flare Type LT	N/A	N/A	Flare Type RT	N/A		
N/A	Flare Slope LT (%)	N/A	N/A	Flare Slope RT (%)	N/A		
N/A	Flare Traversable LT?	N/A	N/A	Flare Traversable RT?	N/A		
N/A	Landing Length (in)	N/A	N/A	DWS Provided?	N/A		
N/A	Landing Width (in)	N/A	N/A	DWS Contrast?	N/A		
N/A	Landing Slope (%)	N/A	N/A	DWS Length (in)	N/A		
N/A	Landing X Slope (%)	N/A	N/A	DWS Full Width?	N/A		
N/A	Landing Curb? (Y/N)	N/A	N/A	DWS Offset (in)	N/A		
N/A	Shared Landing?	N/A					
N/A	Gutter Ponding?	N/A	N/A	Gutter Slope (%)	N/A		
N/A	Gutter Lip Ht (in)	N/A	N/A	Gutter X Slope (%)	N/A		
N/A	Painted X Walk1?	Yes	N/A	Painted X Walk2?	N/A		
	X Walk 1 Direction	To N		X Walk 2 Direction	N/A		
N/A	X Walk 1 Width (in)	112.0	N/A	X Walk 2 Width (in)	N/A

X Walk 1 Slope (%)	2.7		X Walk 2 Slope (%)	N/A		
	X Walk 1 X Slope (%)	0.6		X Walk 2 X Slope (%)	N/A		
N/A	Ramp inside XWalk1?	Yes	N/A	Ramp inside XWalk2?	N/A		
	Road Slope (%)	N/A	N/A	Clear Space?	N/A		
	Road X Slope (%)	N/A	N/A	Clear Space to XWalk (in)	N/A		
N/A	Any Obstructions?	N/A	N/A	Storm Grate/Utility Hazard?	N/A		
	Obstruction Type			Storm Grate/Utility Type			
		N/A			N/A		
MXXXXXXXX			Yes	Surface Condition? (G/P)	Good
