Intersection ID: 45495	Main Street: COTTON_PRESS_RD	Cross Street: TREE_CANOPY_RD	Location:	W
ADA ID: 15B29E904803	Ramp Type: PerpDiag	Initial Pass/Fail: Fail	Overall Compliance: No	Severity Score: 33.75

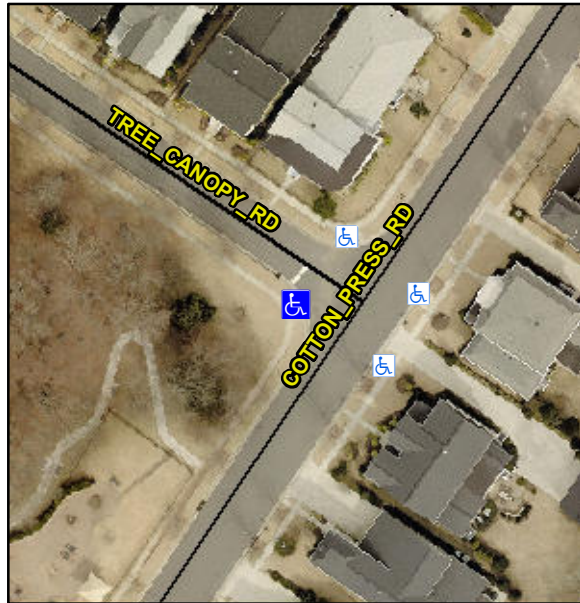
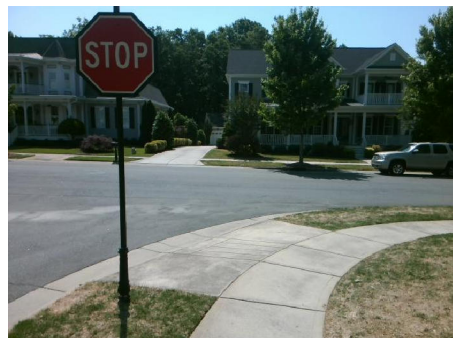
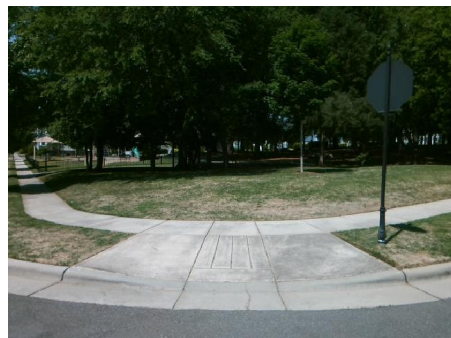
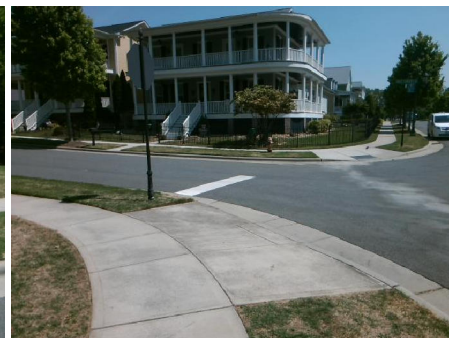
Not Found, R304.5.1, R304.2.2

Possible Solutions:			Compliance	Description	Data	Compliance	Description	Data
Remove & Replace Curb Ramp With Two New Directional Ramps or Equivalent.	N/A	Ramp Length (in)	71.0	No	Ramp Slope (%)	13.6		
	No	Ramp Width (in)	41.0	Yes	Ramp XSlope (%)	1.7		
	N/A	Flare Type LT	N/A	N/A	Flare Type RT	N/A		
	N/A	Flare Slope LT (%)	N/A	N/A	Flare Slope RT (%)	N/A		
	N/A	Flare Traversable LT?	N/A	N/A	Flare Traversable RT?	N/A		
	N/A	Landing Length (in)	N/A	N/A	DWS Provided?	N/A		
	N/A	Landing Width (in)	N/A	N/A	DWS Contrast?	N/A		
	N/A	Landing Slope (%)	N/A	N/A	DWS Length (in)	N/A		
	N/A	Landing X Slope (%)	N/A	N/A	DWS Full Width?	N/A		
	N/A	Landing Curb? (Y/N)	N/A	N/A	DWS Offset (in)	N/A		
Surveyor Notes: N/A	N/A	Shared Landing?	N/A					
	N/A	Gutter Ponding?	N/A	N/A	Gutter Slope (%)	N/A		
	N/A	Gutter Lip Ht (in)	N/A	N/A	Gutter X Slope (%)	N/A		
	N/A	Painted X Walk1?	No	N/A	Painted X Walk2?	No		
		X Walk 1 Direction	To SE		X Walk 2 Direction	To NE

N/A	X Walk 1 Width (in)	N/A	N/A	X Walk 2 Width (in)	N/A		
		X Walk 1 Slope (%)	1.4		X Walk 2 Slope (%)	1.3		
		X Walk 1 X Slope (%)	2.2		X Walk 2 X Slope (%)	1.5		
	N/A	Ramp inside XWalk1?	N/A	N/A	Ramp inside XWalk2?	N/A		
		Road Slope (%)	1.7	N/A	Clear Space?	N/A		
PROW/ADA: Not Found, R304.5.1, R304.2.2		Road X Slope (%)	0.9	N/A	Clear Space to XWalk (in)	N/A		
	N/A	Any Obstructions?	N/A	N/A	Storm Grate/Utility Hazard?	N/A		
		Obstruction Type			Storm Grate/Utility Type			
			N/A			N/A		
				Yes	Surface Condition? (G/P)	Good		
	Total Cost:	\$	3200.00

Remove & Replace Curb Ramp With Two New Directional Ramps or Equivalent.
