# Access Compliance Report

## Public Rights-of-Way

### (Curb Ramps)

Intersection ID: 8867	Main Street: GRANT_ST	Cross Street: LANDER_ST	Location: S
ADA ID: 15B86BACC5D7	Ramp Type: Perp	Initial Pass/Fail: Fail	Overall Compliance: No
Severity Score: 10			
Codes/Mitigation Info/Possible Solution		Field Measurements/Component Compliance

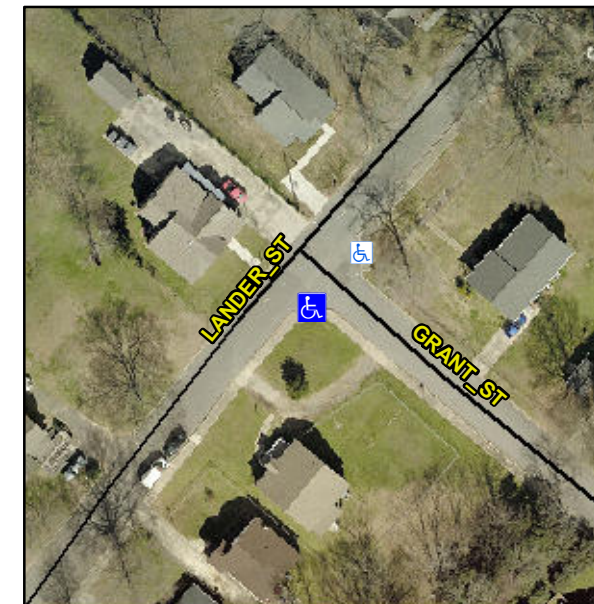
**Not Found, R304.5.1, R304.5.3**

Compliance	Description	Data	Compliance	Description	Data
N/A	Ramp Length (in)	55.5	Yes	Ramp Slope (%)	7.2
No	Ramp Width (in)	47.5	No	Ramp XSlope (%)	2.1
N/A	Flare Type LT	N/A	N/A	Flare Type RT	N/A
N/A	Flare Slope LT (%)	N/A	N/A	Flare Slope RT (%)	N/A
N/A	Flare Traversable LT?	N/A	N/A	Flare Traversable RT?	N/A
N/A	Landing Length (in)	N/A	N/A	DWS Provided?	N/A
N/A	Landing Width (in)	N/A	N/A	DWS Contrast?	N/A
N/A	Landing Slope (%)	N/A	N/A	DWS Length (in)	N/A
N/A	Landing X Slope (%)	N/A	N/A	DWS Full Width?	N/A
N/A	Landing Curb? (Y/N)	N/A	N/A	DWS Offset (in)	N/A
N/A	Shared Landing?	N/A			
N/A	Gutter Ponding?	N/A	N/A	Gutter Slope (%)	N/A
N/A	Gutter Lip Ht (in)	N/A	N/A	Gutter X Slope (%)	N/A
N/A	Painted X Walk1?	No	N/A	Painted X Walk2?	N/A
	X Walk 1 Direction	To NE		X Walk 2 Direction	N/A
N/A	X Walk 1 Width (in)	N/A	N/A	X Walk 2 Width (in)	N/A
	X Walk 1 Slope (%)	2.5		X Walk 2 Slope (%)	N/A
	X Walk 1 X Slope (%)	1.4		X Walk 2 X Slope (%)	N/A

N/A	Ramp inside XWalk1?	N/A	N/A	Ramp inside XWalk2?	N/A
	Road Slope (%)	N/A	N/A	Clear Space?	N/A
	Road X Slope (%)	N/A	N/A	Clear Space to XWalk (in)	N/A
N/A	Any Obstructions?	N/A	N/A	Storm Grate/Utility Hazard?	N/A
	Obstruction Type			Storm Grate/Utility Type	
		N/A			N/A
			Yes	Surface Condition? (G/P)	Good

**Remove & Replace Entire Ramp.**

Total Cost: \$ 1850.00
