Access Compliance Report

Public Rights-of-Way

(Curb Ramps)

Intersection ID: N/A	Main Street: DEERFIELD_MANOR_DR	Cross Street: DEERHURST_LN	Location: SE
ADA ID: 15DCC9397891	Ramp Type: Perp	Initial Pass/Fail: Pass	Overall Compliance: No
		Severity Score: 15

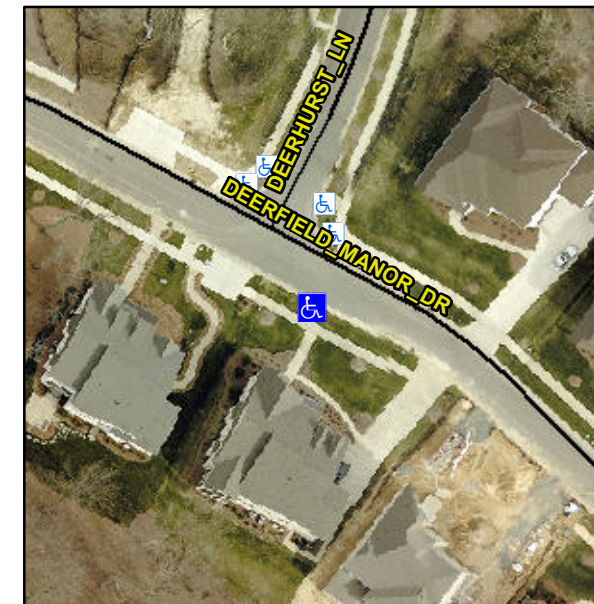
Compliance	Description	Data	Compliance	Description	Data
N/A	Ramp Length (in)	94.0	Yes	Ramp Slope (%)	7.9
Yes	Ramp Width (in)	48.0	Yes	Ramp XSlope (%)	1.5
N/A	Flare Type LT	Sloped	N/A	Flare Type RT	N/A
N/A	Flare Slope LT (%)	4.6	Yes	Flare Slope RT (%)	7.0
N/A	Flare Traversable LT?	Yes	N/A	Flare Traversable RT?	Yes
Yes	Landing Length (in)	59.5	Yes	DWS Provided?	Yes
Yes	Landing Width (in)	60.0	Yes	DWS Contrast?	Yes
Yes	Landing Slope (%)	0.7	Yes	DWS Length (in)	24.0
Yes	Landing X Slope (%)	0.6	Yes	DWS Full Width?	Yes
N/A	Landing Curb? (Y/N)	No	No	DWS Offset (in)	4.0
N/A	Shared Landing?	No			
Yes	Gutter Ponding?	No	Yes	Gutter Slope (%)	2.8
No	Gutter Lip Ht (in)	1.0	Yes	Gutter X Slope (%)	1.9
N/A	Painted X Walk1?	No	N/A	Painted X Walk2?	N/A
	X Walk 1 Direction	To NE		X Walk 2 Direction	N/A
N/A	X Walk 1 Width (in)	N/A	N/A	X Walk 2 Width (in)	N/A
	X Walk 1 Slope (%)	2.9		X Walk 2 Slope (%)	N/A
	X Walk 1 X Slope (%)	0.8		X Walk 2 X Slope (%)	N/A

N/A	Ramp inside XWalk1?	N/A	N/A	Ramp inside XWalk2?	N/A
	Road Slope (%)	N/A	N/A	Clear Space?	Yes
	Road X Slope (%)	N/A	N/A	Clear Space to XWalk (in)	N/A
Yes	Any Obstructions?	No	Yes	Storm Grate/Utility Hazard?	No
	Obstruction Type			Storm Grate/Utility Type	
		N/A			N/A
			Yes	Surface Condition? (G/P)	Good

Possible Solutions:

Remove & Replace Detectable Warning System. Grind Gutter Lip.

R305.2, R302.7.2
