Access Compliance Report

Public Rights-of-Way

(Curb Ramps)

Intersection ID: 22310	Main Street: OAK_CREEK_DR	Cross Street: SARDIS_RD	Location: W
ADA ID: 15E5EC896616	Ramp Type: PerpDiag	Initial Pass/Fail: Fail	Overall Compliance: No
Severity Score: 46.25			
Codes/Mitigation Info/Possible Solution		Field Measurements/Component Compliance

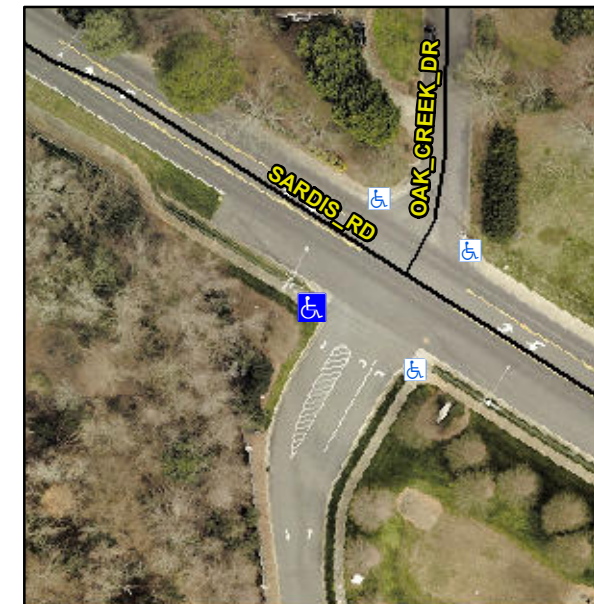
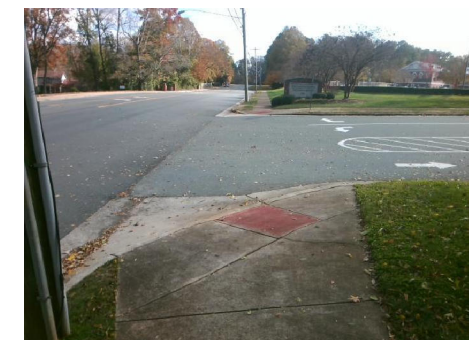
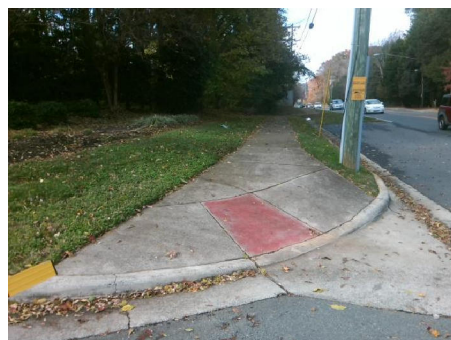
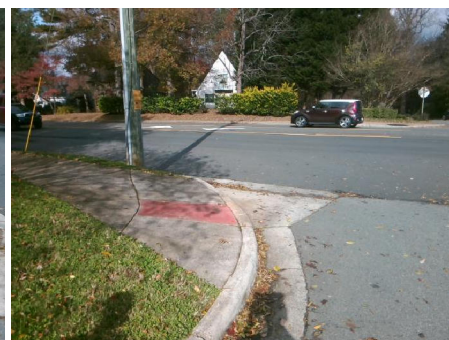
Not Found, R304.5.1, R304.2.2, R304.5.3

Compliance	Description	Data	Compliance	Description	Data
N/A	Ramp Length (in)	60.0	No	Ramp Slope (%)	15.3
No	Ramp Width (in)	38.0	No	Ramp XSlope (%)	5.2
N/A	Flare Type LT	N/A	N/A	Flare Type RT	N/A
N/A	Flare Slope LT (%)	N/A	N/A	Flare Slope RT (%)	N/A
N/A	Flare Traversable LT?	N/A	N/A	Flare Traversable RT?	N/A
N/A	Landing Length (in)	N/A	N/A	DWS Provided?	N/A
N/A	Landing Width (in)	N/A	N/A	DWS Contrast?	N/A
N/A	Landing Slope (%)	N/A	N/A	DWS Length (in)	N/A
N/A	Landing X Slope (%)	N/A	N/A	DWS Full Width?	N/A
N/A	Landing Curb? (Y/N)	N/A	N/A	DWS Offset (in)	N/A
N/A	Shared Landing?	N/A			
N/A	Gutter Ponding?	N/A	N/A	Gutter Slope (%)	N/A
N/A	Gutter Lip Ht (in)	N/A	N/A	Gutter X Slope (%)	N/A
N/A	Painted X Walk1?	No	N/A	Painted X Walk2?	No
	X Walk 1 Direction	To SE		X Walk 2 Direction	To NE
N/A	X Walk 1 Width (in)	N/A	N/A	X Walk 2 Width (in)	N/A
	X Walk 1 Slope (%)	5.3		X Walk 2 Slope (%)	10.6
	X Walk 1 X Slope (%)	6.1		X Walk 2 X Slope (%)	0.8

N/A	Ramp inside XWalk1?	N/A	N/A	Ramp inside XWalk2?	N/A
	Road Slope (%)	6.3	N/A	Clear Space?	N/A
	Road X Slope (%)	3.1	N/A	Clear Space to XWalk (in)	N/A
N/A	Any Obstructions?	N/A	N/A	Storm Grate/Utility Hazard?	N/A
	Obstruction Type			Storm Grate/Utility Type	
		N/A			N/A
			Yes	Surface Condition? (G/P)	Good

Remove & Replace Curb Ramp With Two New Directional Ramps or Equivalent.
