Access Compliance Report

Public Rights-of-Way

(Curb Ramps)

Intersection ID: 44810	Main Street: NEVIN_RD	Cross Street: VICTORY_LN	Location: SE
ADA ID: 15E9D0414B04	Ramp Type: PerpDiag	Initial Pass/Fail: Fail	Overall Compliance: No
		Severity Score: 21.25

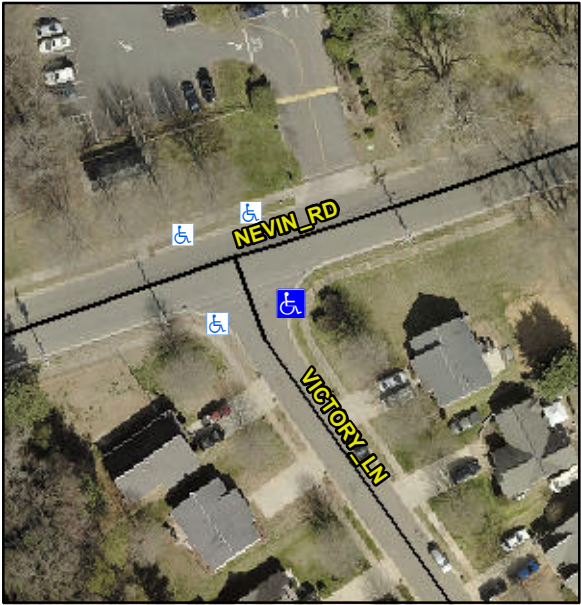
Possible Solutions:		Compliance	Description	Data
	Remove & Replace Curb Ramp With Two New Directional Ramps or Equivalent.		N/A	Ramp Length (in)	48.0
			No	Ramp Width (in)	44.0
			N/A	Flare Type LT	N/A
			N/A	Flare Slope LT (%)	N/A
			N/A	Flare Traversable LT?	N/A
			N/A	Landing Length (in)	N/A
			N/A	Landing Width (in)	N/A
			N/A	Landing Slope (%)	N/A
			N/A	Landing X Slope (%)	N/A
<p>Surveyor Notes:</p> <p>N/A</p> <p>PROW/ADA:</p> <p>R304.5.1, R304.5.3</p>			N/A	Flare Type RT	N/A
			N/A	Flare Slope RT (%)	N/A
			N/A	Flare Traversable RT?	N/A
			N/A	DWS Provided?	N/A
			N/A	DWS Contrast?	N/A
			N/A	DWS Length (in)	N/A
			N/A	DWS Full Width?	N/A
			N/A	DWS Offset (in)	N/A
			N/A	Gutter Ponding?	N/A
			N/A	Gutter Lip Ht (in)	N/A
<p>Total Cost:</p> <p>\$ 3200.00</p>			No	Painted X Walk1?	No
				X Walk 1 Direction	To N
			N/A	X Walk 1 Width (in)	N/A

X Walk 1 Slope (%)	8.3
				X Walk 1 X Slope (%)	2.3
			N/A	Ramp inside XWalk1?	N/A
				Road Slope (%)	5.9
				Road X Slope (%)	7.2
			N/A	Any Obstructions?	N/A
				Obstruction Type	
			N/A	Storm Grate/Utility Hazard?	N/A
				Storm Grate/Utility Type	
			N/A		N/A
			Yes	Surface Condition? (G/P)	Good
