Access Compliance Report

Public Rights-of-Way

(Curb Ramps)

Intersection ID: 10028935	Main Street: IDLEWILD_RD	Cross Street: N/A	Location: SE
ADA ID: 15EFA709CF71	Ramp Type: PerpDiag	Initial Pass/Fail: Fail	Overall Compliance: No
Codes/Mitigation Info/Possible Solution		Field Measurements/Component Compliance	
Severity Score: 31.25

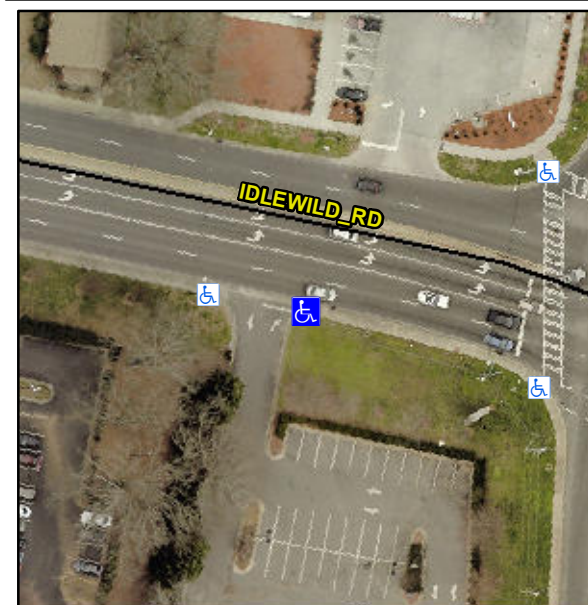
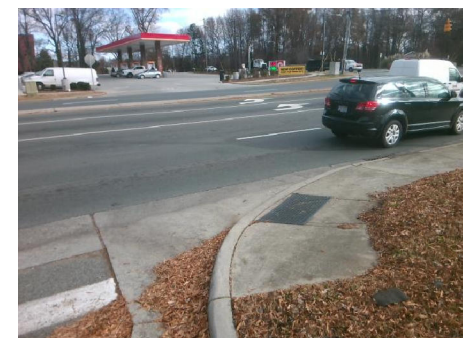
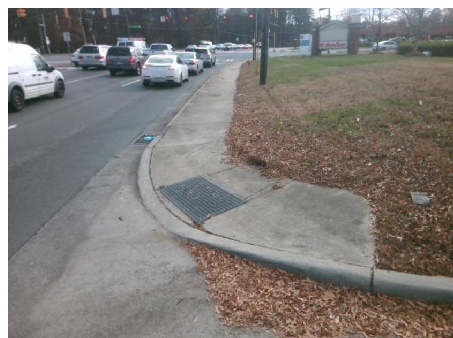
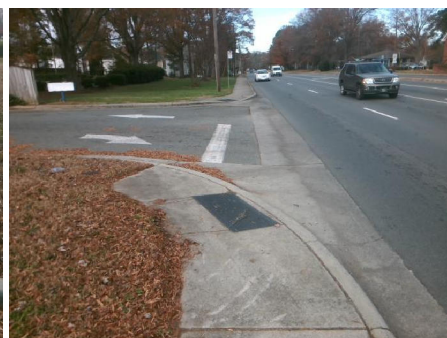
Not Found, R304.5.1, R304.2.2, R304.5.3

Compliance	Description	Data	Compliance	Description	Data
N/A	Ramp Length (in)	58.0	No	Ramp Slope (%)	11.6
No	Ramp Width (in)	35.0	No	Ramp XSlope (%)	3.0
N/A	Flare Type LT	N/A	N/A	Flare Type RT	N/A
N/A	Flare Slope LT (%)	N/A	N/A	Flare Slope RT (%)	N/A
N/A	Flare Traversable LT?	N/A	N/A	Flare Traversable RT?	N/A
N/A	Landing Length (in)	N/A	N/A	DWS Provided?	N/A
N/A	Landing Width (in)	N/A	N/A	DWS Contrast?	N/A
N/A	Landing Slope (%)	N/A	N/A	DWS Length (in)	N/A
N/A	Landing X Slope (%)	N/A	N/A	DWS Full Width?	N/A
N/A	Landing Curb? (Y/N)	N/A	N/A	DWS Offset (in)	N/A
N/A	Shared Landing?	N/A			
N/A	Gutter Ponding?	N/A	N/A	Gutter Slope (%)	N/A
N/A	Gutter Lip Ht (in)	N/A	N/A	Gutter X Slope (%)	N/A
N/A	Painted X Walk1?	No	N/A	Painted X Walk2?	No
	X Walk 1 Direction	To NE		X Walk 2 Direction	To NW
N/A	X Walk 1 Width (in)	N/A	N/A	X Walk 2 Width (in)	N/A
	X Walk 1 Slope (%)	0.8		X Walk 2 Slope (%)	1.8
	X Walk 1 X Slope (%)	0.4		X Walk 2 X Slope (%)	2.6

N/A	Ramp inside XWalk1?	N/A	N/A	Ramp inside XWalk2?	N/A
	Road Slope (%)	0.9	N/A	Clear Space?	N/A
	Road X Slope (%)	3.0	N/A	Clear Space to XWalk (in)	N/A
N/A	Any Obstructions?	N/A	N/A	Storm Grate/Utility Hazard?	N/A
	Obstruction Type			Storm Grate/Utility Type	
		N/A			N/A
			Yes	Surface Condition? (G/P)	Good

Remove & Replace Curb Ramp With Two New Directional Ramps or Equivalent.
