# Access Compliance Report

## Public Rights-of-Way

### (Curb Ramps)

Intersection ID: 29756	Main Street: KING_ARTHUR_DR	Cross Street: NIMUE_CT	Location: NW
ADA ID: 15F70A36A790	Ramp Type: PerpDiag	Initial Pass/Fail: Fail	Overall Compliance: No
Severity Score: 8.75			
Codes/Mitigation Info/Possible Solution		Field Measurements/Component Compliance

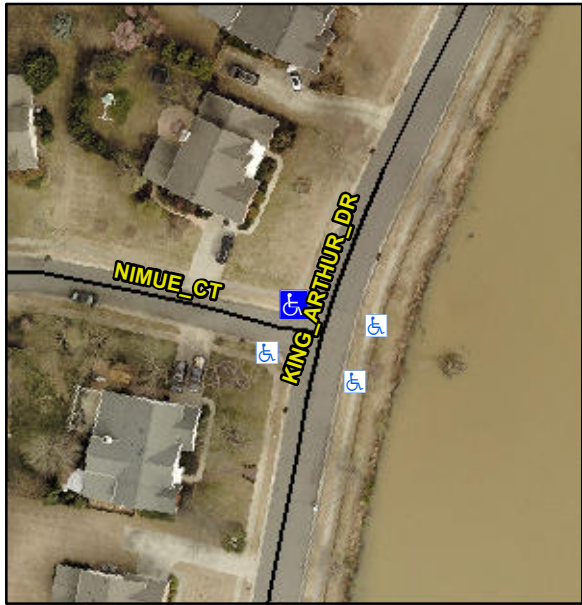
Compliance	Description	Data	Compliance	Description	Data
N/A	Ramp Length (in)	48.0	Yes	Ramp Slope (%)	8.0
No	Ramp Width (in)	47.0	Yes	Ramp XSlope (%)	0.9
N/A	Flare Type LT	N/A	N/A	Flare Type RT	N/A
N/A	Flare Slope LT (%)	N/A	N/A	Flare Slope RT (%)	N/A
N/A	Flare Traversable LT?	N/A	N/A	Flare Traversable RT?	N/A
N/A	Landing Length (in)	N/A	N/A	DWS Provided?	N/A
N/A	Landing Width (in)	N/A	N/A	DWS Contrast?	N/A
N/A	Landing Slope (%)	N/A	N/A	DWS Length (in)	N/A
N/A	Landing X Slope (%)	N/A	N/A	DWS Full Width?	N/A
N/A	Landing Curb? (Y/N)	N/A	N/A	DWS Offset (in)	N/A
N/A	Shared Landing?	N/A			
N/A	Gutter Ponding?	N/A	N/A	Gutter Slope (%)	N/A
N/A	Gutter Lip Ht (in)	N/A	N/A	Gutter X Slope (%)	N/A
N/A	Painted X Walk1?	No	N/A	Painted X Walk2?	No
	X Walk 1 Direction	To SW		X Walk 2 Direction	To SE
N/A	X Walk 1 Width (in)	N/A	N/A	X Walk 2 Width (in)	N/A
	X Walk 1 Slope (%)	0.6		X Walk 2 Slope (%)	3.9
	X Walk 1 X Slope (%)	1.5		X Walk 2 X Slope (%)	0.9

N/A	Ramp inside XWalk1?	N/A	N/A	Ramp inside XWalk2?	N/A
	Road Slope (%)	1.7	N/A	Clear Space?	N/A
	Road X Slope (%)	3.3	N/A	Clear Space to XWalk (in)	N/A
N/A	Any Obstructions?	N/A	N/A	Storm Grate/Utility Hazard?	N/A
	Obstruction Type			Storm Grate/Utility Type	
		N/A			N/A
			Yes	Surface Condition? (G/P)	Good

Possible Solutions:					
	Remove & Replace Curb Ramp With Two New Directional Ramps or Equivalent.					
	Surveyor Notes:					
	N/A					
	PROW/ADA:					
	R304.5.1					
Street 1 Name	NIMUE CT					
Stop Condition-Street 2	StopSign					
Street 2 Name	KING ARTHUR DR					
Stop Condition-Street 1	None					
Total Cost:		\$	3200.00
