## Access Compliance Report Public Rights-of-Way (Curb Ramps)

Intersection ID: 19174 Main Street: RENWICK\_RD Cross Street: SARDIS\_RD Location: SE

ADA ID: 15F80F16B04F Ramp Type: Perp Initial Pass/Fail: Fail Overall Compliance: No Severity Score: 12.5

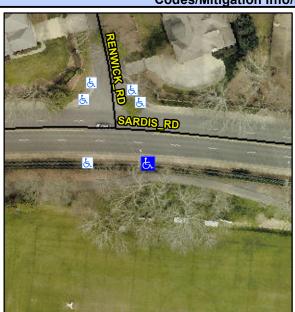
Field Measurements/Component Compliance						
Comp	liance Description	Data	Compl	iance	Description	Data
N/A	Ramp Length (in)	60.0	No	Ramp	Slope (%)	11.1
Yes	Ramp Width (in)	48.0	Yes	Ramp	XSlope (%)	0.5
N/A	Flare Type LT	N/A	N/A	Flare	Type RT	N/A
N/A	Flare Slope LT (%)	N/A	N/A	Flare	Slope RT (%)	N/A
N/A	Flare Traversable LT?	N/A	N/A	Flare	Traversable RT?	N/A
N/A	Landing Length (in)	N/A	N/A	DWS	Provided?	N/A
N/A	Landing Width (in)	N/A	N/A	DWS	Contrast?	N/A
N/A	Landing Slope (%)	N/A	N/A	DWS	Length (in)	N/A
N/A	Landing X Slope (%)	N/A	N/A	DWS	Full Width?	N/A
N/A	Landing Curb? (Y/N)	N/A	N/A	DWS	Offset (in)	N/A
N/A	Shared Landing?	N/A				
N/A	Gutter Ponding?	N/A	N/A	Gutte	r Slope (%)	N/A
N/A	Gutter Lip Ht (in)	N/A	N/A	Gutte	r X Slope (%)	N/A
N/A	Painted X Walk1?	No	N/A	Painte	ed X Walk2?	N/A
	X Walk 1 Direction	To N		X Wa	lk 2 Direction	N/A
N/A	X Walk 1 Width (in)	N/A	N/A	X Wa	lk 2 Width (in)	N/A
	X Walk 1 Slope (%)	1.9		X Wa	lk 2 Slope (%)	N/A

X Walk 1 X Slope (%)	0.3		X Wa	lk 2 X Slope (%)	N/A
N/A	Ramp inside XWalk1?	N/A	N/A	Ramp	inside XWalk2?	N/A
	Road Slope (%)	N/A	N/A	Clear	Space?	N/A
	Road X Slope (%)	N/A	N/A	Clear	Space to XWalk (in)	N/A
N/A	Any Obstructions?	N/A	N/A	Storm	Grate/Utility Hazard?	N/A
	Obstruction Type			Storm	Grate/Utility Type	
		N/A				N/A
			Yes	Surfa	ce Condition? (G/P)	Good
301	(4)(4)(4)

/Possible Solution	
Possible Solutions:	Comp
Remove & Replace Entire Ramp.	N/A
·	Yes
	N/A
	N/A
	N/A
	N/A
Surveyor Notes:	N/A
N/A	N/A
	N/A
	N/A
	N/A
PROW/ADA:	N/A
Not Found, R304.2.2	N/A
	N/A
	N/A
	N/A

1850.00
