Access Compliance Report

Public Rights-of-Way

(Curb Ramps)

Intersection ID: N/A		Main Street: BALLANTYNE CORPORATE_P		Cross Street: N/A		Location: NE													
ADA ID: 15F8724B5DE0		Ramp Type: Directional1		Initial Pass/Fail: Fail		Overall Compliance: No		Severity Score: 10											
Codes/Mitigation Info/Possible Solution				Field Measurements/Component Compliance															
<div>

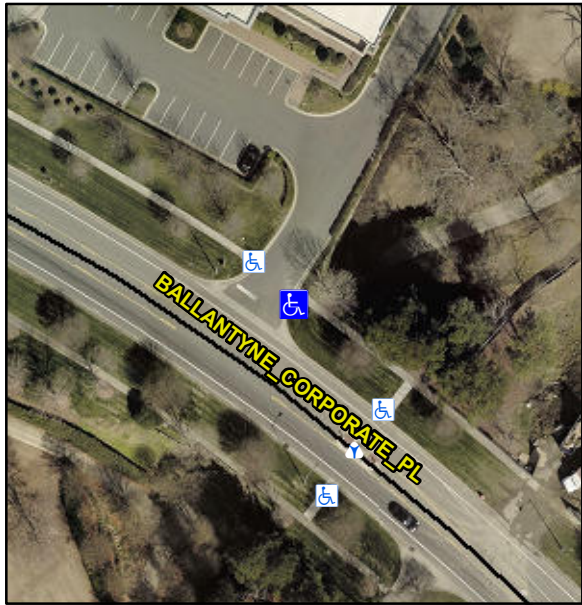
</div> <div>Street 1 NameENTRANCE</div> <div>Stop Condition-Street 1StopSign</div> <div>Street 2 NameN/A</div> <div>Stop Condition-Street 2N/A</div>				Possible Solutions:		Compliance		Description		Data		Compliance		Description		Data			
				Remove & Replace Entire Ramp.		N/A		Ramp Length (in)		74.0		N/A		Grade Break?		N/A		N/A	
						No		Ramp Width (in)		44.0		N/A		Grade Break Slope (%)		0.0		0.0	
						Yes		Ramp Slope (%)		1.2		N/A		Grade Break XSlope (%)		0.0		0.0	
						No		Ramp XSlope (%)		4.6									
						N/A		Flare Type LT		N/A		N/A		Flare Type RT		N/A		N/A	
						N/A		Flare Slope LT (%)		N/A		N/A		Flare Slope RT (%)		0.0		0.0

N/A		Flare Traversable LT?		N/A		N/A		Flare Traversable RT?		N/A		N/A	
						N/A		Landing Length (in)		0.0		N/A		DWS Provided?		N/A		N/A	
						N/A		Landing Width (in)		0.0		N/A		DWS Contrast?		N/A		N/A	
						N/A		Landing Slope (%)		0.0		N/A		DWS Length (in)		N/A		N/A	
						N/A		Landing X Slope (%)		0.0		N/A		DWS Full Width?		N/A		N/A	
						N/A		Landing Curb? (Y/N)		N/A		N/A		DWS Offset LT (in)		N/A		N/A	
						N/A		Shared Landing?		N/A		N/A		DWS Offset RT (in)		N/A		N/A	
						N/A		Gutter Ponding?		0.0		N/A		Gutter Slope (%)		N/A		N/A	
						N/A		Gutter Lip Ht (in)		0.0		N/A		Gutter X Slope (%)		N/A		N/A	
						N/A		Painted X Walk1?		No				Road Slope (%)		3.3		3.3	
								X Walk 1 Direction		To NW				Road X Slope (%)		3.5		3.5	
								X Walk 1 Width (in)		N/A				Clear Space?		N/A		N/A	
								X Walk 1 Slope (%)		3.3		N/A		Clear Space to XWalk (in)		N/A		N/A	
				X Walk 1 X Slope (%)		3.5		N/A		Storm Grate/Utility Hazard?		N/A		N/A

N/A		Ramp inside XWalk1?		N/A		Storm Grate/Utility Type									
				N/A		Any Obstructions?		N/A						N/A					
						Obstruction Type		Yes		Surface Condition? (G/P)		Good		Good					
								N/A		N/A		Curb Slope (%)		1.7					
		Total Cost:		\$		1600.00
